# Facility Condition Assessment

## Campus Summary

November 02, 2017

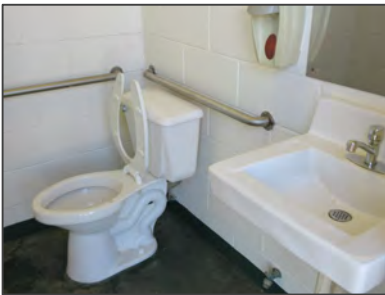
Painted flooring was observed to be in poor condition. The floor finish system was observed to have stains and worn patterns from high traffic use.

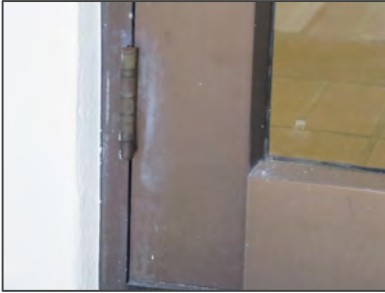
Exterior doors frames and finishes are faded and chipped. Deteriorated door hardware could be a security issue in the future.

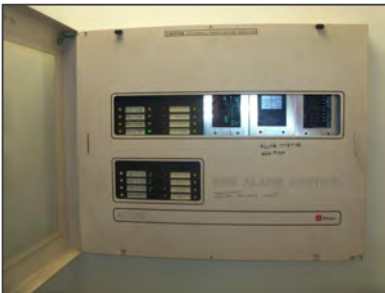
Fire alarm and detection system is expired due to age and condition.

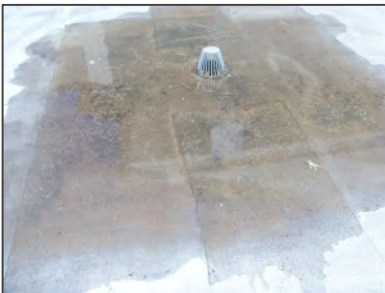
Built-up roof covering was in poor condition. Tears and holes were observed. The fabric is worn, and leaks will become more frequent. Rain water drainage was observed to be inadequate due to roof slope.

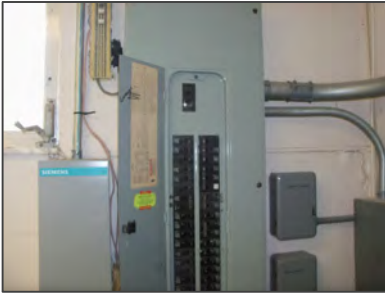
100-225-amp local panels. Service and distribution is beyond its BOMA recommended service life. System is in poor condition with many breakers missing or no longer working.

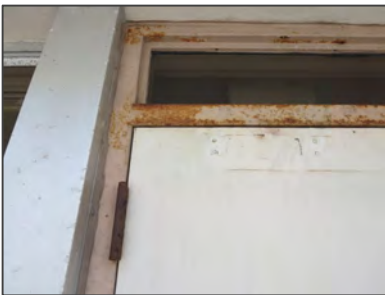
Exterior doors frames are rusted, and doors finishes are faded and chipped. Doors are misaligned, and operation is rough. Rusted door hardware could be a security issue in the future.

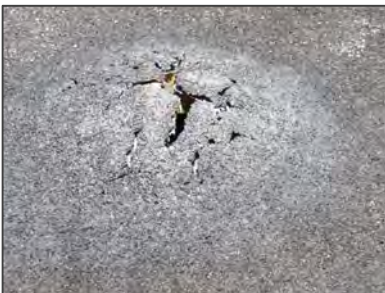
The built-up roof covering was in poor condition. Tears and holes were observed. The materials were worn, and leaks will become more frequent. Rain water drainage was observed to be inadequate due to roof slope.

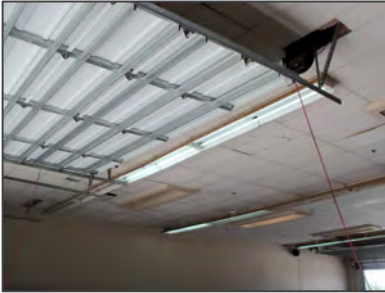
The lighting system appears to be mostly original. Although functional, the lighting system is beyond the average service life as predicted by BOMA.

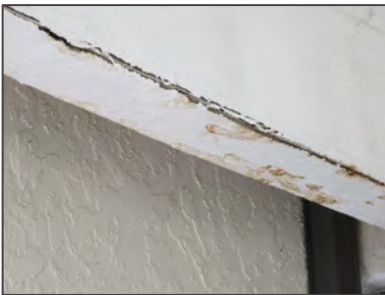
Exterior wall finishes were comprised of stucco with painted trim. Systems were observed to be in poor condition.

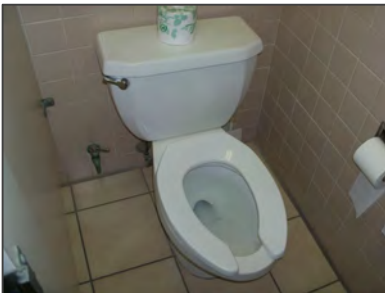
Plumbing piping and sanitary sewer presumed to be original. Although functional, the systems are beyond the average service life as predicted by BOMA.

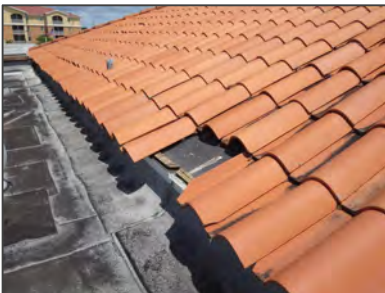
The built-up roof system was observed to have tears and holes. A section of roof area is covered with ceramic tile which was also in poor condition.

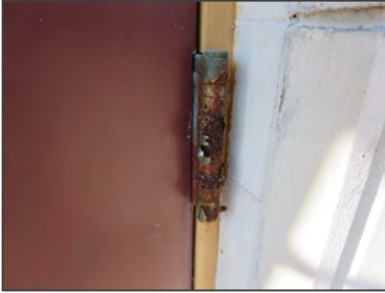
Door hardware and finishes are faded and chipped. Rusted door hardware could be a security issue in the future.

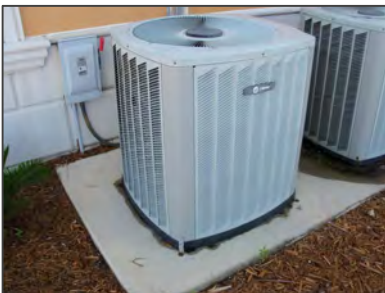
HVAC units utilize R-22 refrigerant. In 2020 R-22 refrigerant will be limited and servicing existing equipment will need to use recycled refrigerant.

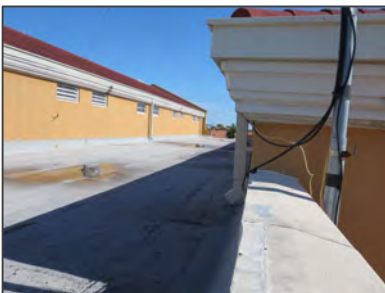
The roofing system consists of modified bitumen in good condition. Rain water drainage was observed to be inadequate due to roof slope.

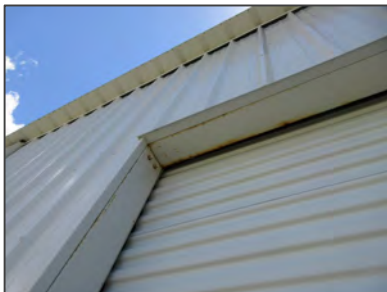
Roll up and side entrance doors are in fair condition. Peeling and chipping paint on wood trim and metal frame is showing signs of rust.

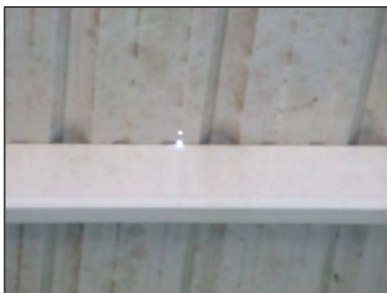
Metal panels were observed to be rusting and have exceeded their BOMA predicted useful life. Holes were observed from the interior of the facility.

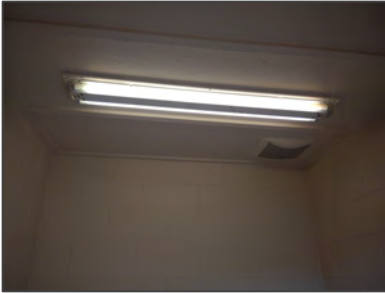
Lighting is inadequate for the space and past its useful service life.

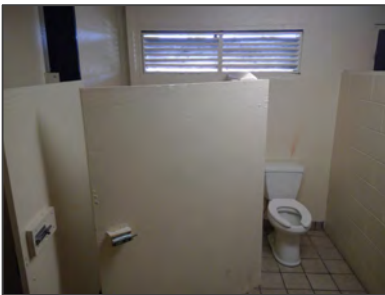
Wooden partitions are damaged, and some hardware is broken. High use has decreased the remaining useful life.

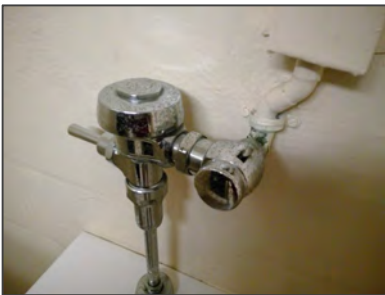
Domestic water and sanitary sewer piping is original to the building and beyond BOMA predicted service life. Fixtures are in fair to poor condition. Finishes are worn, and handles are broken.

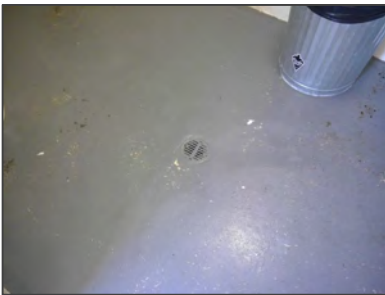
The floor finish system was observed to have stains and heavy wear. System expected life reduced due to condition.

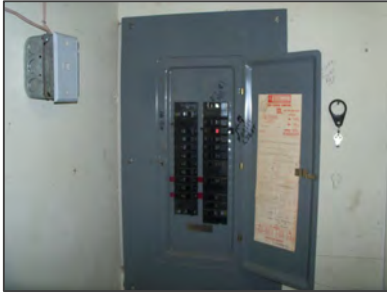
The electrical system appears to be mostly original. Although functional, the electrical system is beyond the average service life as predicted by BOMA.

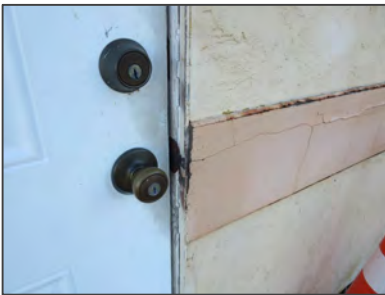
Doors frames are rusted, and finishes are faded and chipped. Doors are misaligned, and operation is rough. Rusted door hardware could be a security issue in the future.

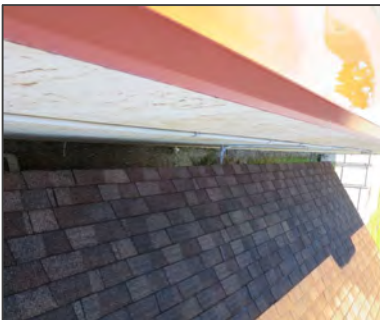
A section of the asphalt shingles has been damaged due to weather. Repair is recommended to avoid damage to interior finishes.

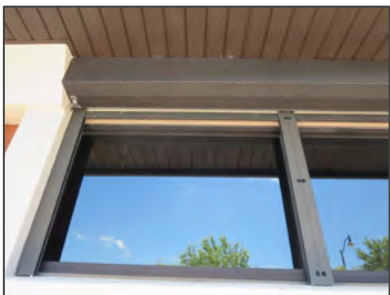
Exterior window system is comprised of metal frames with double pane glass. Deteriorated finish was observed.

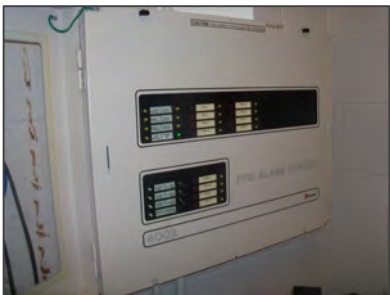
Fire alarm and detection system is comprised of pull stations. No deficiencies reported or observed. System assumed to be original based on the model and type. System expired due to age and risk.

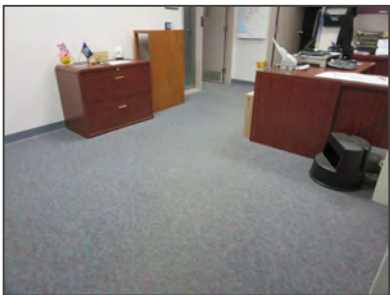
Carpeted floors are near the end of their BOMA predicted life cycle. Carpet was observed to be in fair condition with minor stains.

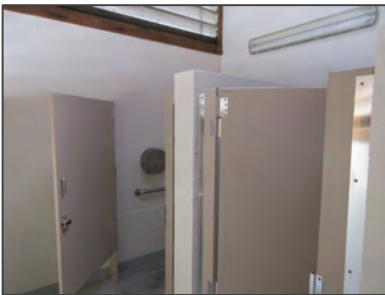
Wooden laminated partitions are damaged, and some hardware is broken. High use has decreased the remaining useful life.

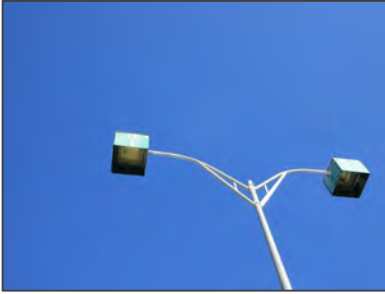
The exterior parking lot lights were observed to be heavily corroded.

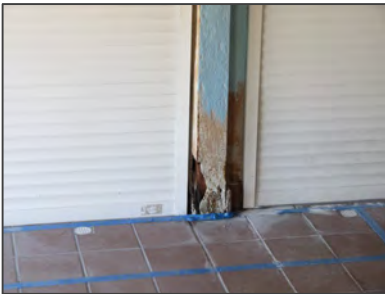
Door system is comprised of roll up doors and hollow metal. Door frames are rusting.

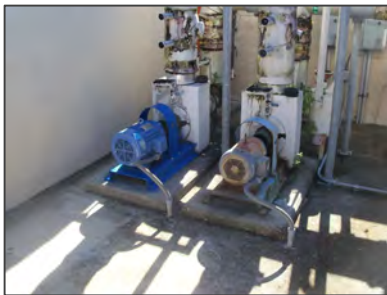
Insulation at exterior chilled water lines has deteriorated and become ineffective in some locations.

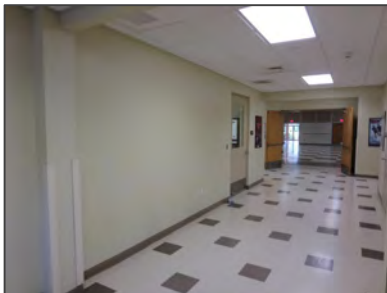
Floor Finish system is comprised of resilient and ceramic tile. System expired due to condition.

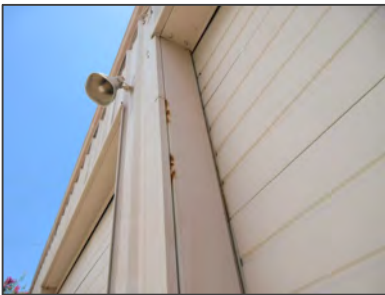
Factory finished metal panels are rusting and damaged in many locations. Construction sealants were observed to be desiccated and missing.

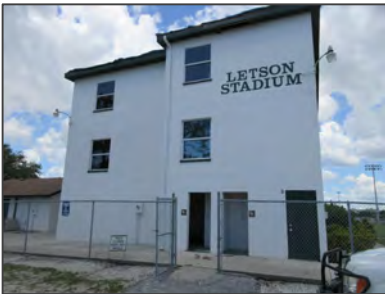
Exterior wall finishes were comprised of stucco with painted trim. Systems were observed to be in fair condition.

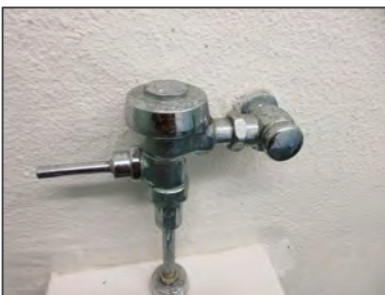
Domestic water and sanitary sewer piping is original to the building and beyond BOMA predicted service life. Fixtures are in fair to poor condition. Finishes are worn.

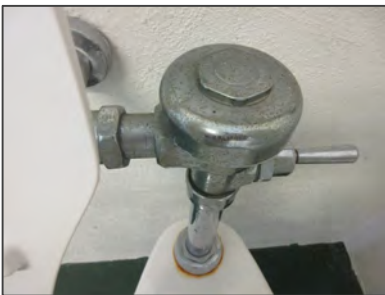
Much of the plumbing fixture's caulking and sealants have deteriorated due to age. Fixtures are beyond its service life.

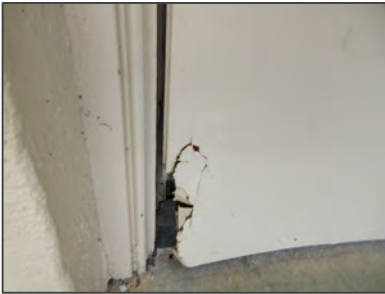
Maintenance exterior door frames are rusted, and doors finishes are faded and chipped. Rusted door hardware could be a security issue in the future.
