Facility Condition Assessment

Campus Summary

November 02, 2017

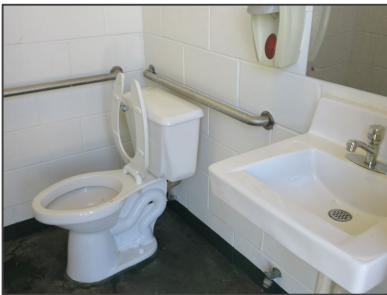
Painted flooring was observed to be in poor condition. The floor finish system was observed to have stains and worn patterns from high traffic use.

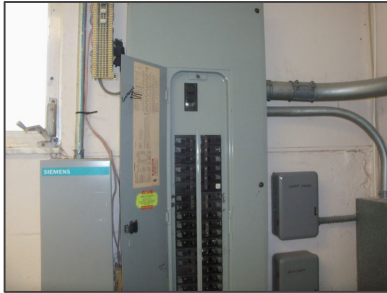
100-225-amp local panels. Service and distribution is beyond its BOMA recommended service life. System is in poor condition with many breakers missing or no longer working.

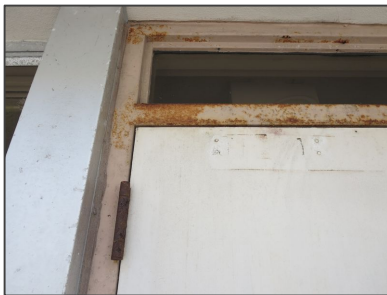
Exterior doors frames are rusted, and doors finishes are faded and chipped. Doors are misaligned, and operation is rough. Rusted door hardware could be a security issue in the future.

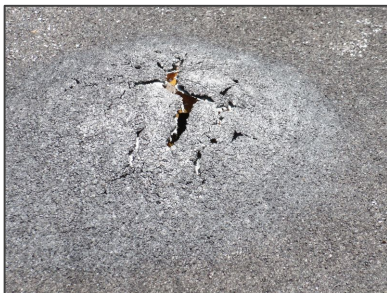
The built-up roof covering was in poor condition. Tears and holes were observed. The materials were worn, and leaks will become more frequent. Rain water drainage was observed to be inadequate due to roof slope.

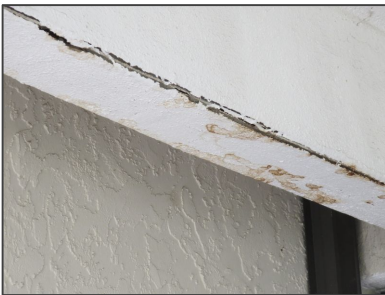
Exterior wall finishes were comprised of stucco with painted trim. Systems were observed to be in poor condition.

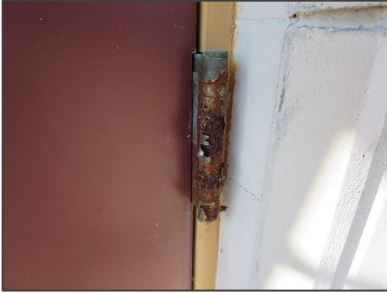
Door hardware and finishes are faded and chipped. Rusted door hardware could be a security issue in the future.

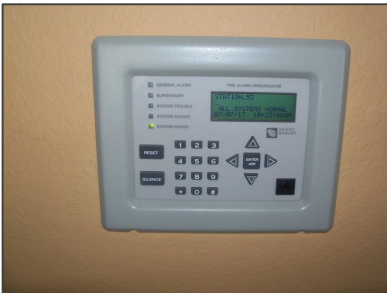
Fire alarm and detection system is comprised of pull stations. No deficiencies reported or observed.

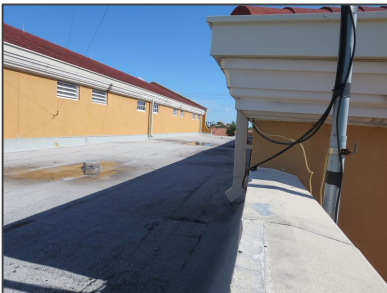
The roofing system consists of modified bitumen in good condition. Rain water drainage was observed to be inadequate due to roof slope.

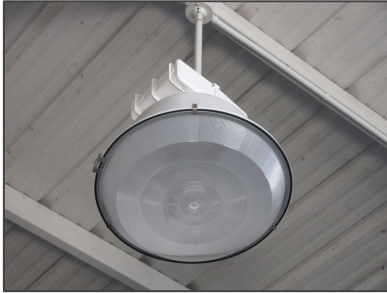
Lighting system is comprised of halogen lighting. Systems are in good condition. No issues observed or reported.

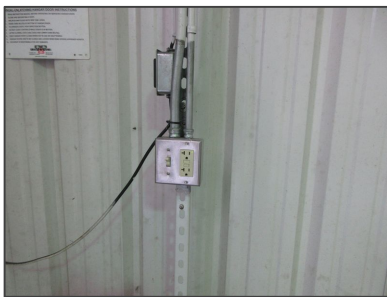
The light switch observed is functioning. GFCI plugs were installed in locations required by current building and safety codes.

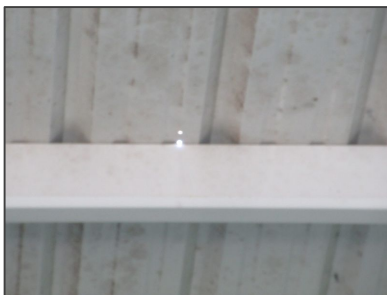
Metal panels were observed to be rusting and have exceeded their BOMA predicted useful life. Holes were observed from the interior of the facility.

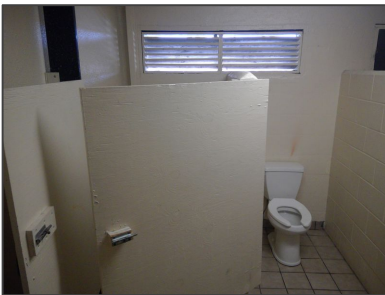
Wooden partitions are damaged, and some hardware is broken. High use has decreased the remaining useful life.

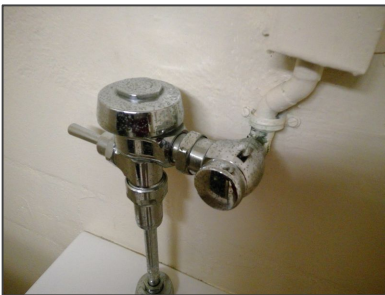
Domestic water and sanitary sewer piping is original to the building and beyond BOMA predicted service life. Fixtures are in fair to poor condition. Finishes are worn, and handles are broken.

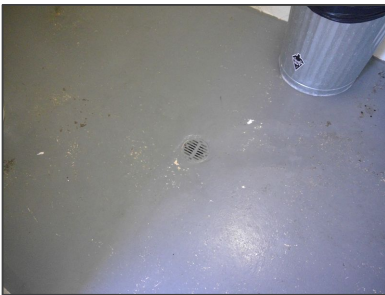
The floor finish system was observed to have stains and heavy wear. System expected life reduced due to condition.

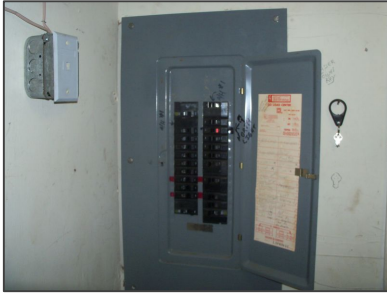
The electrical system appears to be mostly original. Although functional, the electrical system is beyond the average service life as predicted by BOMA.

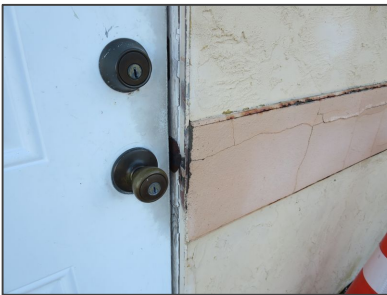
Doors frames are rusted, and finishes are faded and chipped. Doors are misaligned, and operation is rough. Rusted door hardware could be a security issue in the future.

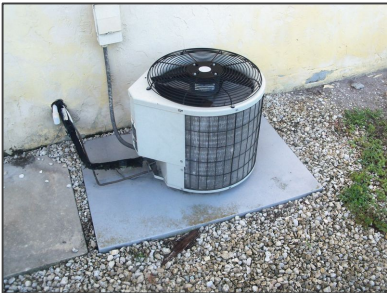
The split-DX units use R-22 refrigerant; insulation at exterior DX lines is deteriorated in many locations. Although the system is functioning and is well maintained, the units are near the end of average service life.

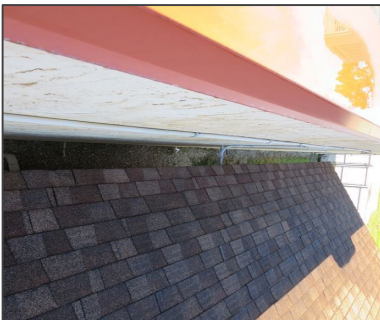
A section of the asphalt shingles has been damaged due to weather. Repair is recommended to avoid damage to interior finishes.

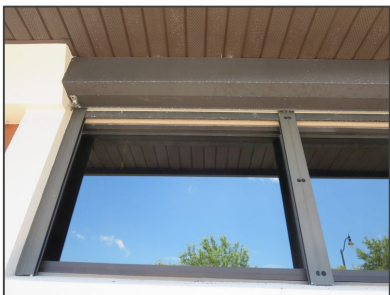
Exterior window system is comprised of metal frames with double pane glass. Deteriorated finish was observed.

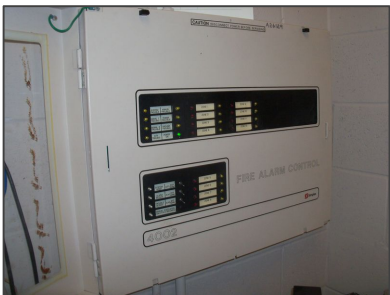
Fire alarm and detection system is comprised of pull stations. No deficiencies reported or observed. System assumed to be original based on the model and type. System expired due to age and risk.

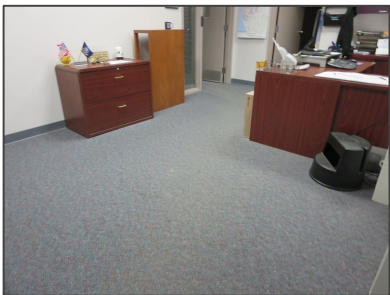
Carpeted floors are near the end of their BOMA predicted life cycle. Carpet was observed to be in fair condition with minor stains.

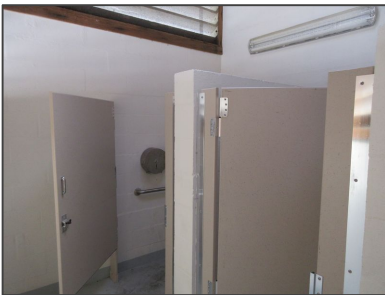
Wooden laminated partitions are damaged, and some hardware is broken. High use has decreased the remaining useful life.

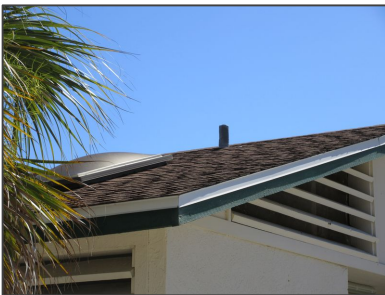
Asphalt roofing system was observed to be in good condition. No issues observed or reported.

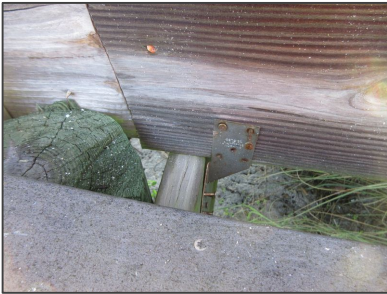
Joist hangers were found to be deteriorated, and nails were observed to be loose.

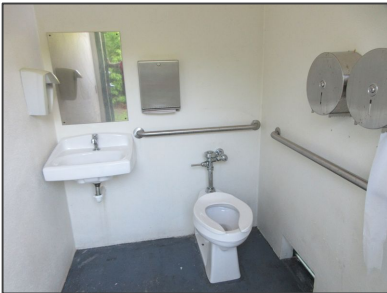
All fixtures were observed to be in good condition. Manual flush valves and sink fixtures were noted.

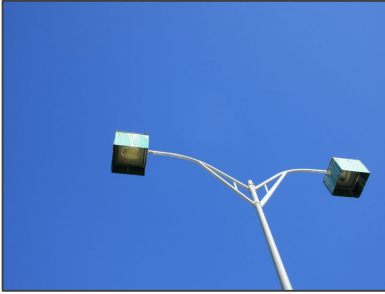
The exterior parking lot lights were observed to be heavily corroded.

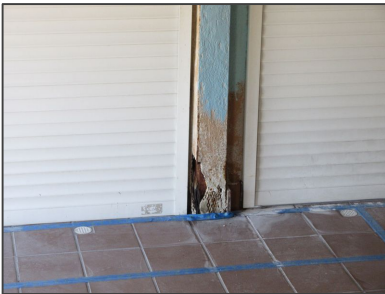
Door system is comprised of roll up doors and hollow metal. Door frames are rusting.

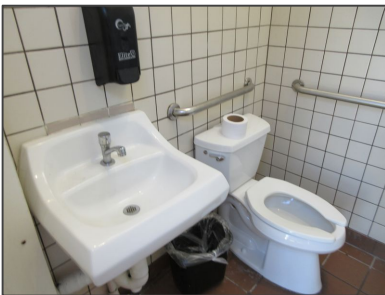
All fixtures were observed to be in good condition. Manual flush valves and sink fixtures were noted.

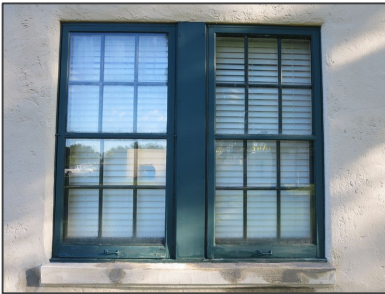
The window system consists of wood frames without insulated glass noted to be in fair condition. Useful life reduced due to condition.

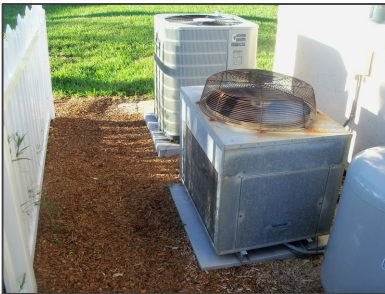
The split-DX units are original and use R-22 refrigerant. Insulation at exterior DX lines is deteriorated in many locations. Although the system is functioning and is well maintained, the units are near the end of average service life.

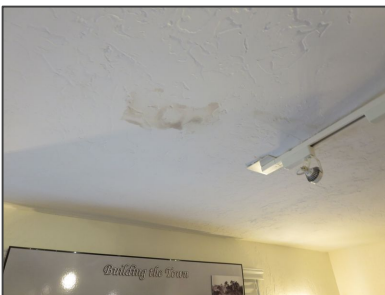
The painted hard surfaces were observed to be in poor condition. The damage could be from roof leaks or leaking HVAC water pipes. The ceiling system is expired due to condition.

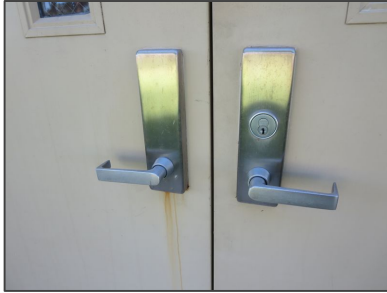
Maintenance exterior doors frames are rusted, and doors finishes are faded and chipped. Rusted door hardware could be a security issue in the future.

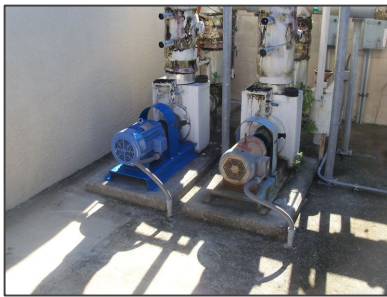
Insulation at exterior chilled water lines has deteriorated and become ineffective in some locations.

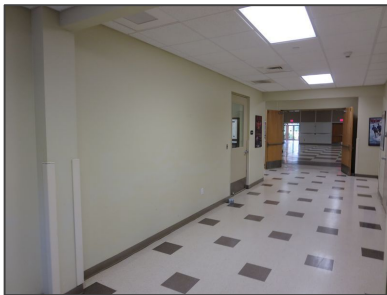
Floor Finish system is comprised of resilient and ceramic tile. System expired due to condition.

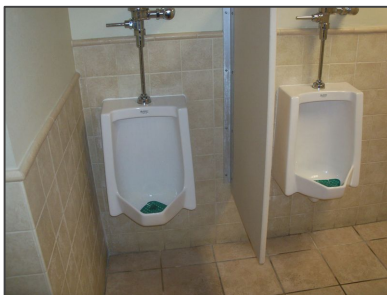
All fixtures were observed to be in good condition. Manual flush valves and sink fixtures were noted.

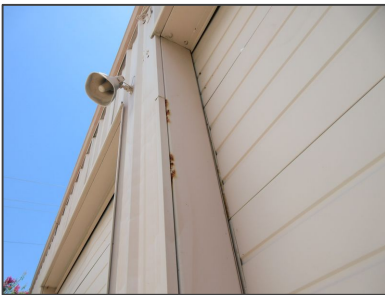
Factory finished metal panels are rusting and damaged in many locations. Construction sealants were observed to be desiccated and missing.

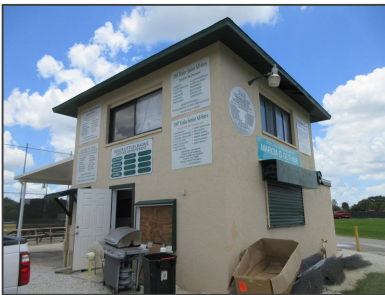
Exterior wall finishes were comprised of stucco with painted trim. Systems were observed to be in fair condition.

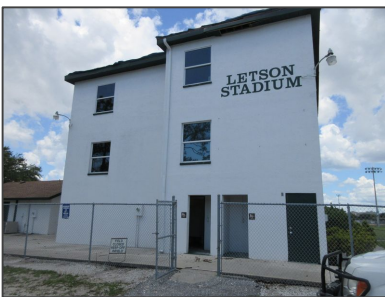
Exterior wall finishes were comprised of stucco with painted trim. Systems were observed to be in fair condition.

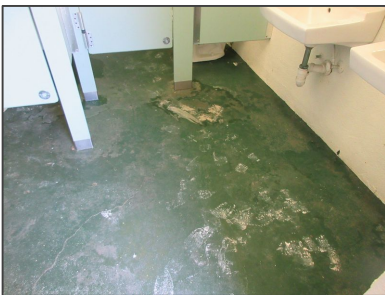
The floor finish system was observed to have stains and show heavy wear from high traffic. System expired due to condition.

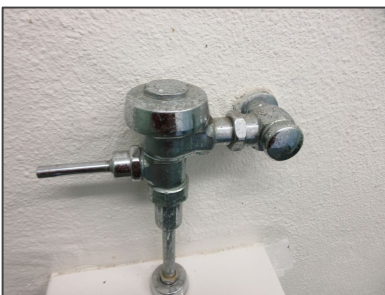
Domestic water and sanitary sewer piping is original to the building and beyond BOMA predicted service life. Fixtures are in fair to poor condition. Finishes are worn.

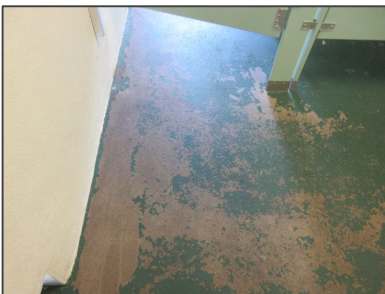
The floor finish system was observed to have stains and show heavy wear from high traffic. System expired due to condition.

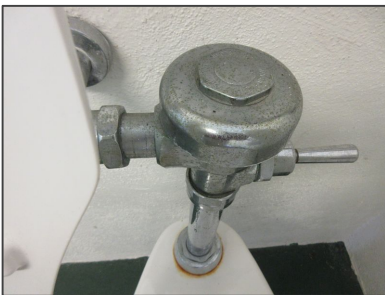
Much of the plumbing fixture's caulking and sealants have deteriorated due to age. Fixtures are beyond its service life.

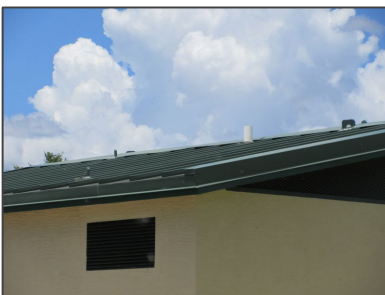
The standing seam roof was found to be in overall good condition. No issues observed or reported.

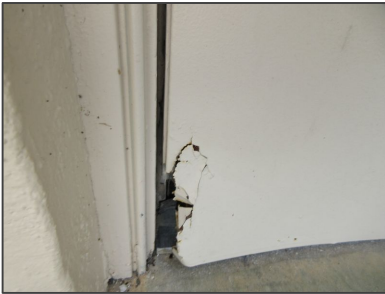
Maintenance exterior door frames are rusted, and doors finishes are faded and chipped. Rusty door hardware could be a security issue in the future.

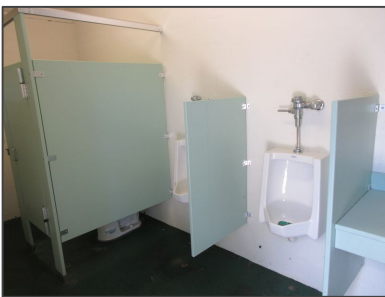
The toilet partitions were found to be in good condition. No issues observed or reported.
