**MEMORANDUM  
FINANCE DEPARTMENT**

**DATE:** April 13, 2018  
**MEETING DATE:** April 24, 2018  
**SUBJECT:** Approval of Ranking for RFQ 3079-18 Construction Management at Risk Services for the City of Venice Public Safety Facility

**An Ajax Building Corporation  
Incident Investigation Report**

**Quinlan Enterprises  
Crane Collapse  
St Petersburg Police Facility Project  
April 5, 2018**

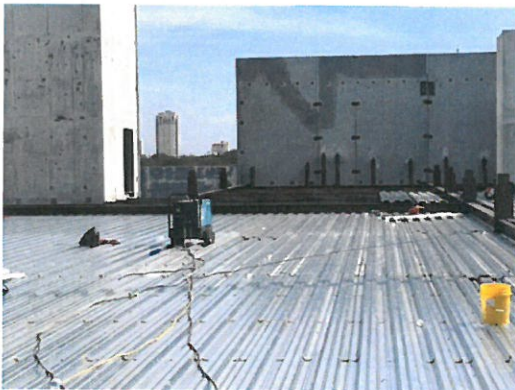
Pictures 1 Controlled decking zone not installed as required.

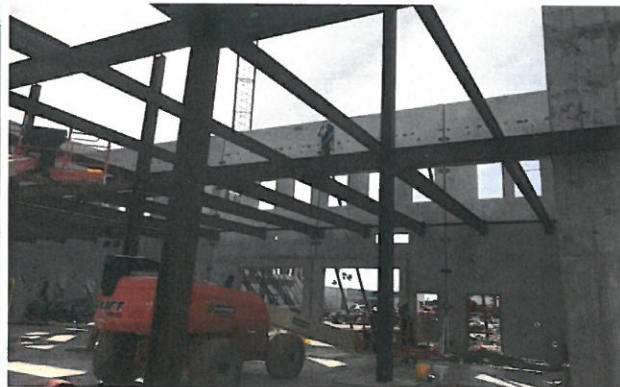
Picture 2 Steel erector not tied off as required. Worker was permanently removed from the project. We conducted a meeting with Allan, superintendent of Quinlan Enterprises, to discuss safety violations from today's inspection. Any personnel not tied off will be removed from the project. The control decking zone will be established by the morning of 2/8 or Ajax will procure the materials and back charge for such.

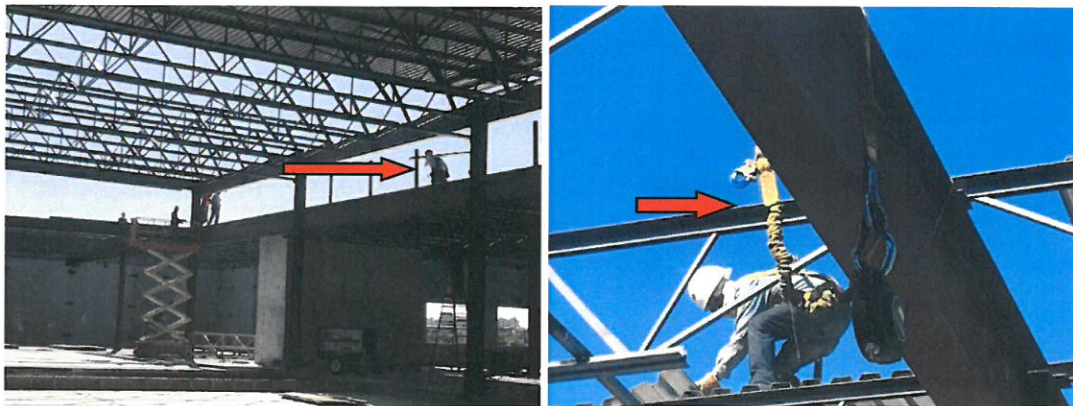
Photo #1 – Steel erector was observed on the edge of the roof deck without being tied off as required.

Photo #2 – Steel erector was observed using a lanyard as a beam strap to anchor a retractable lanyard.
