**AUBURN ROAD  
VENICE, SARASOTA COUNTY, FL**

**SARASOTA COUNTY  
REZONE APPLICATION**

**ENVIRONMENTAL ASSESSMENT REPORT**

**June 6, 2024**

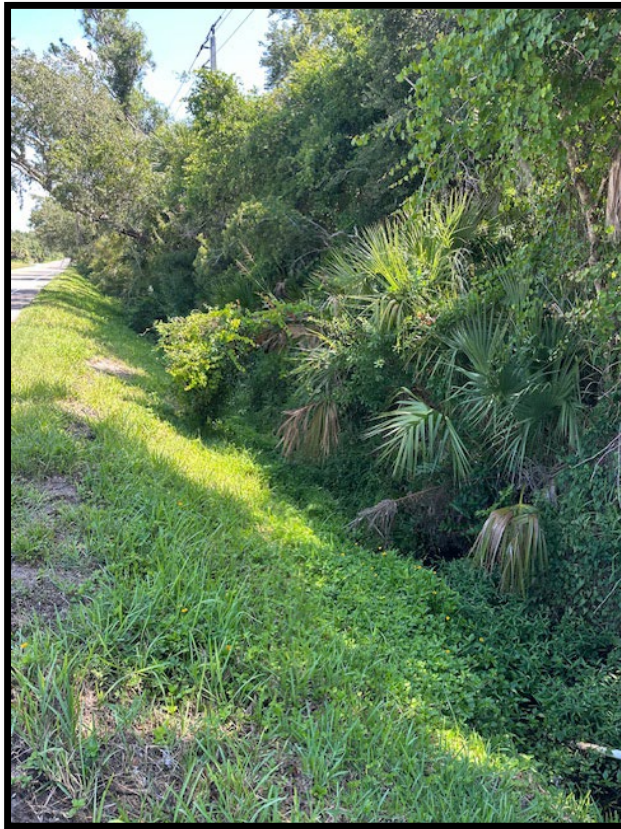
**Photograph 1. Roadside Ditch**

A roadside ditch runs along the west side of the property on the east side of Auburn Road. It's a deeply incised ditch that appears to be maintained and mowed regularly. Vegetation in the bottom of the ditch is dominated by smartweed (*Persicaria hydropiperoides*), leather fern (*Acrostichum danaeifolium*) and primrose willow (*Ludwigia peruviana*). The east side of the ditch is densely vegetated with oaks and cabbage palms at top of bank. The ditch also drains north into Blackburn Canal. Representative photographs of the ditch are included in the enclosed photolog (Appendix A).

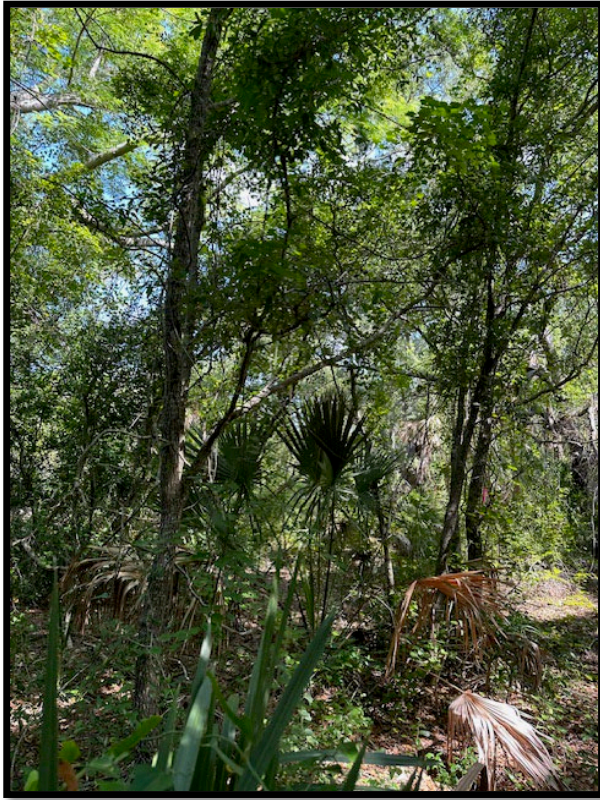
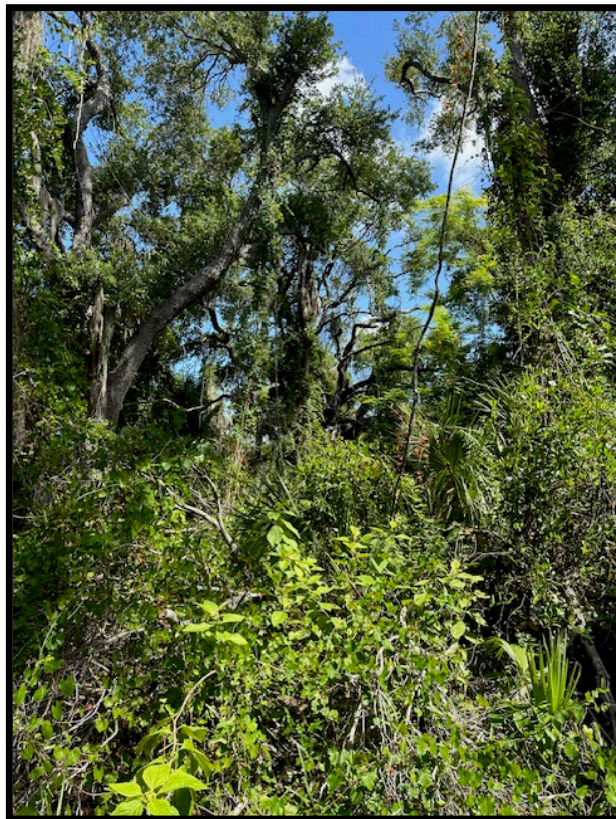
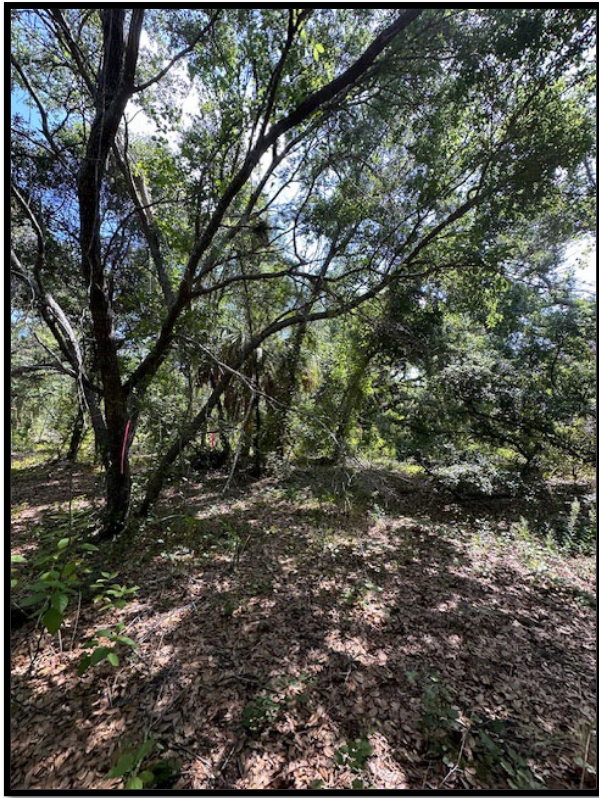
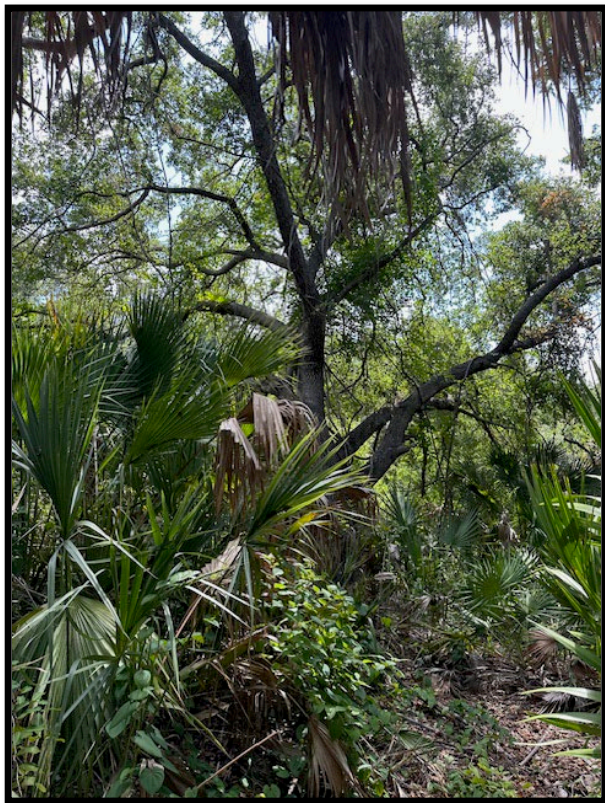
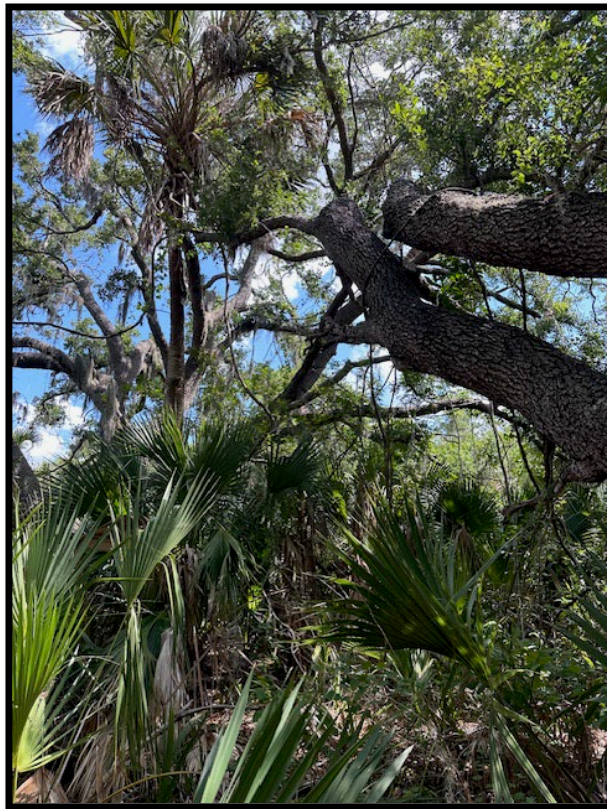
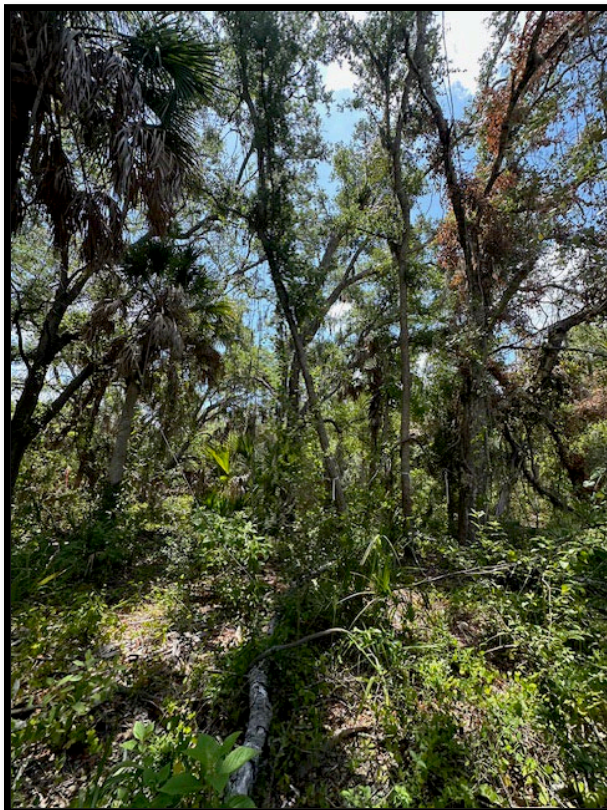
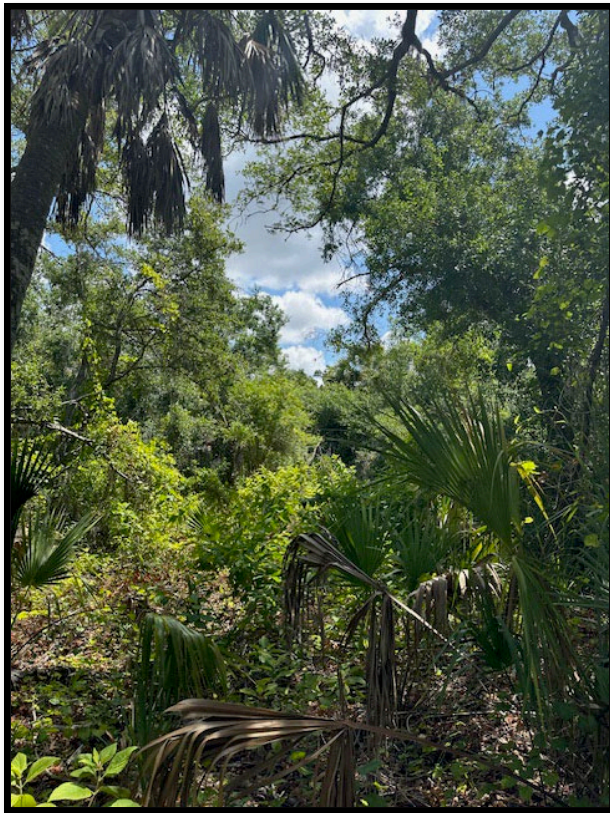
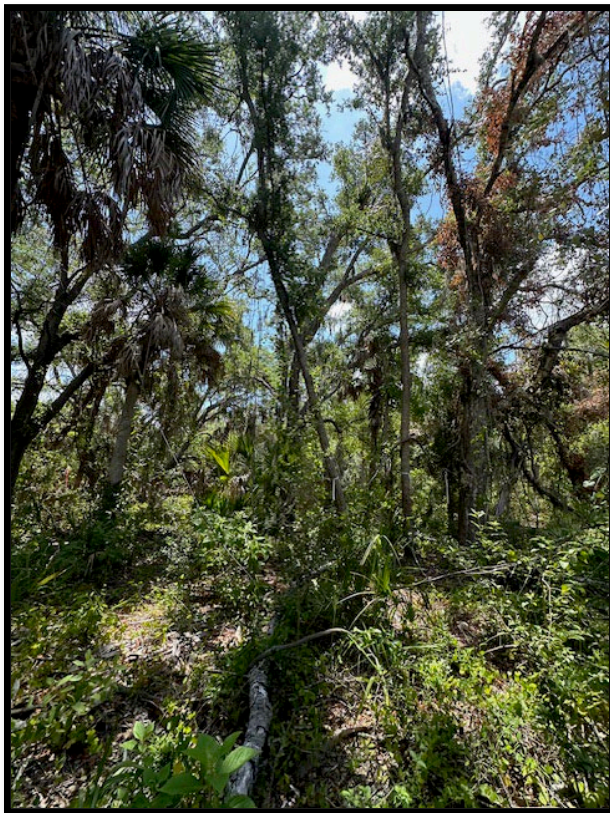
Most of the uplands are wooded areas that are dominated by a canopy of live oaks, laurel oaks, and cabbage palms intermixed with some scattered invasive species and non-native palms including earpod tree (*Enterolobium cyclocarpum*) and queen palms (*Syagrus romanzoffiana*). Most of the understory is disturbed with invasive species and appears to have been cleared historically. The understory consists of cabbage palm saplings, saw palmetto (*Serenoa repens*), Brazilian pepper (*Schinus terebinthifolius*), camphor tree (*Cinnamomum camphora*), carrotwood (*Cupaniopsis anacardoides*), reclinata palms (*Phoenix reclinata*), American beautyberry (*Callicarpa americana*), bracken fern (*Pteridium aquilinum*), wild coffee (*Psychotria nervosa*), prickly pear (*Opuntia* sp.), grapevine (*Vitus* sp.), laurel greenbriar (*Smilax laurifolia*) and air potato (*Dioscorea bulbifera*). Representative photographs of the mixed hardwood areas are included in Appendix A.

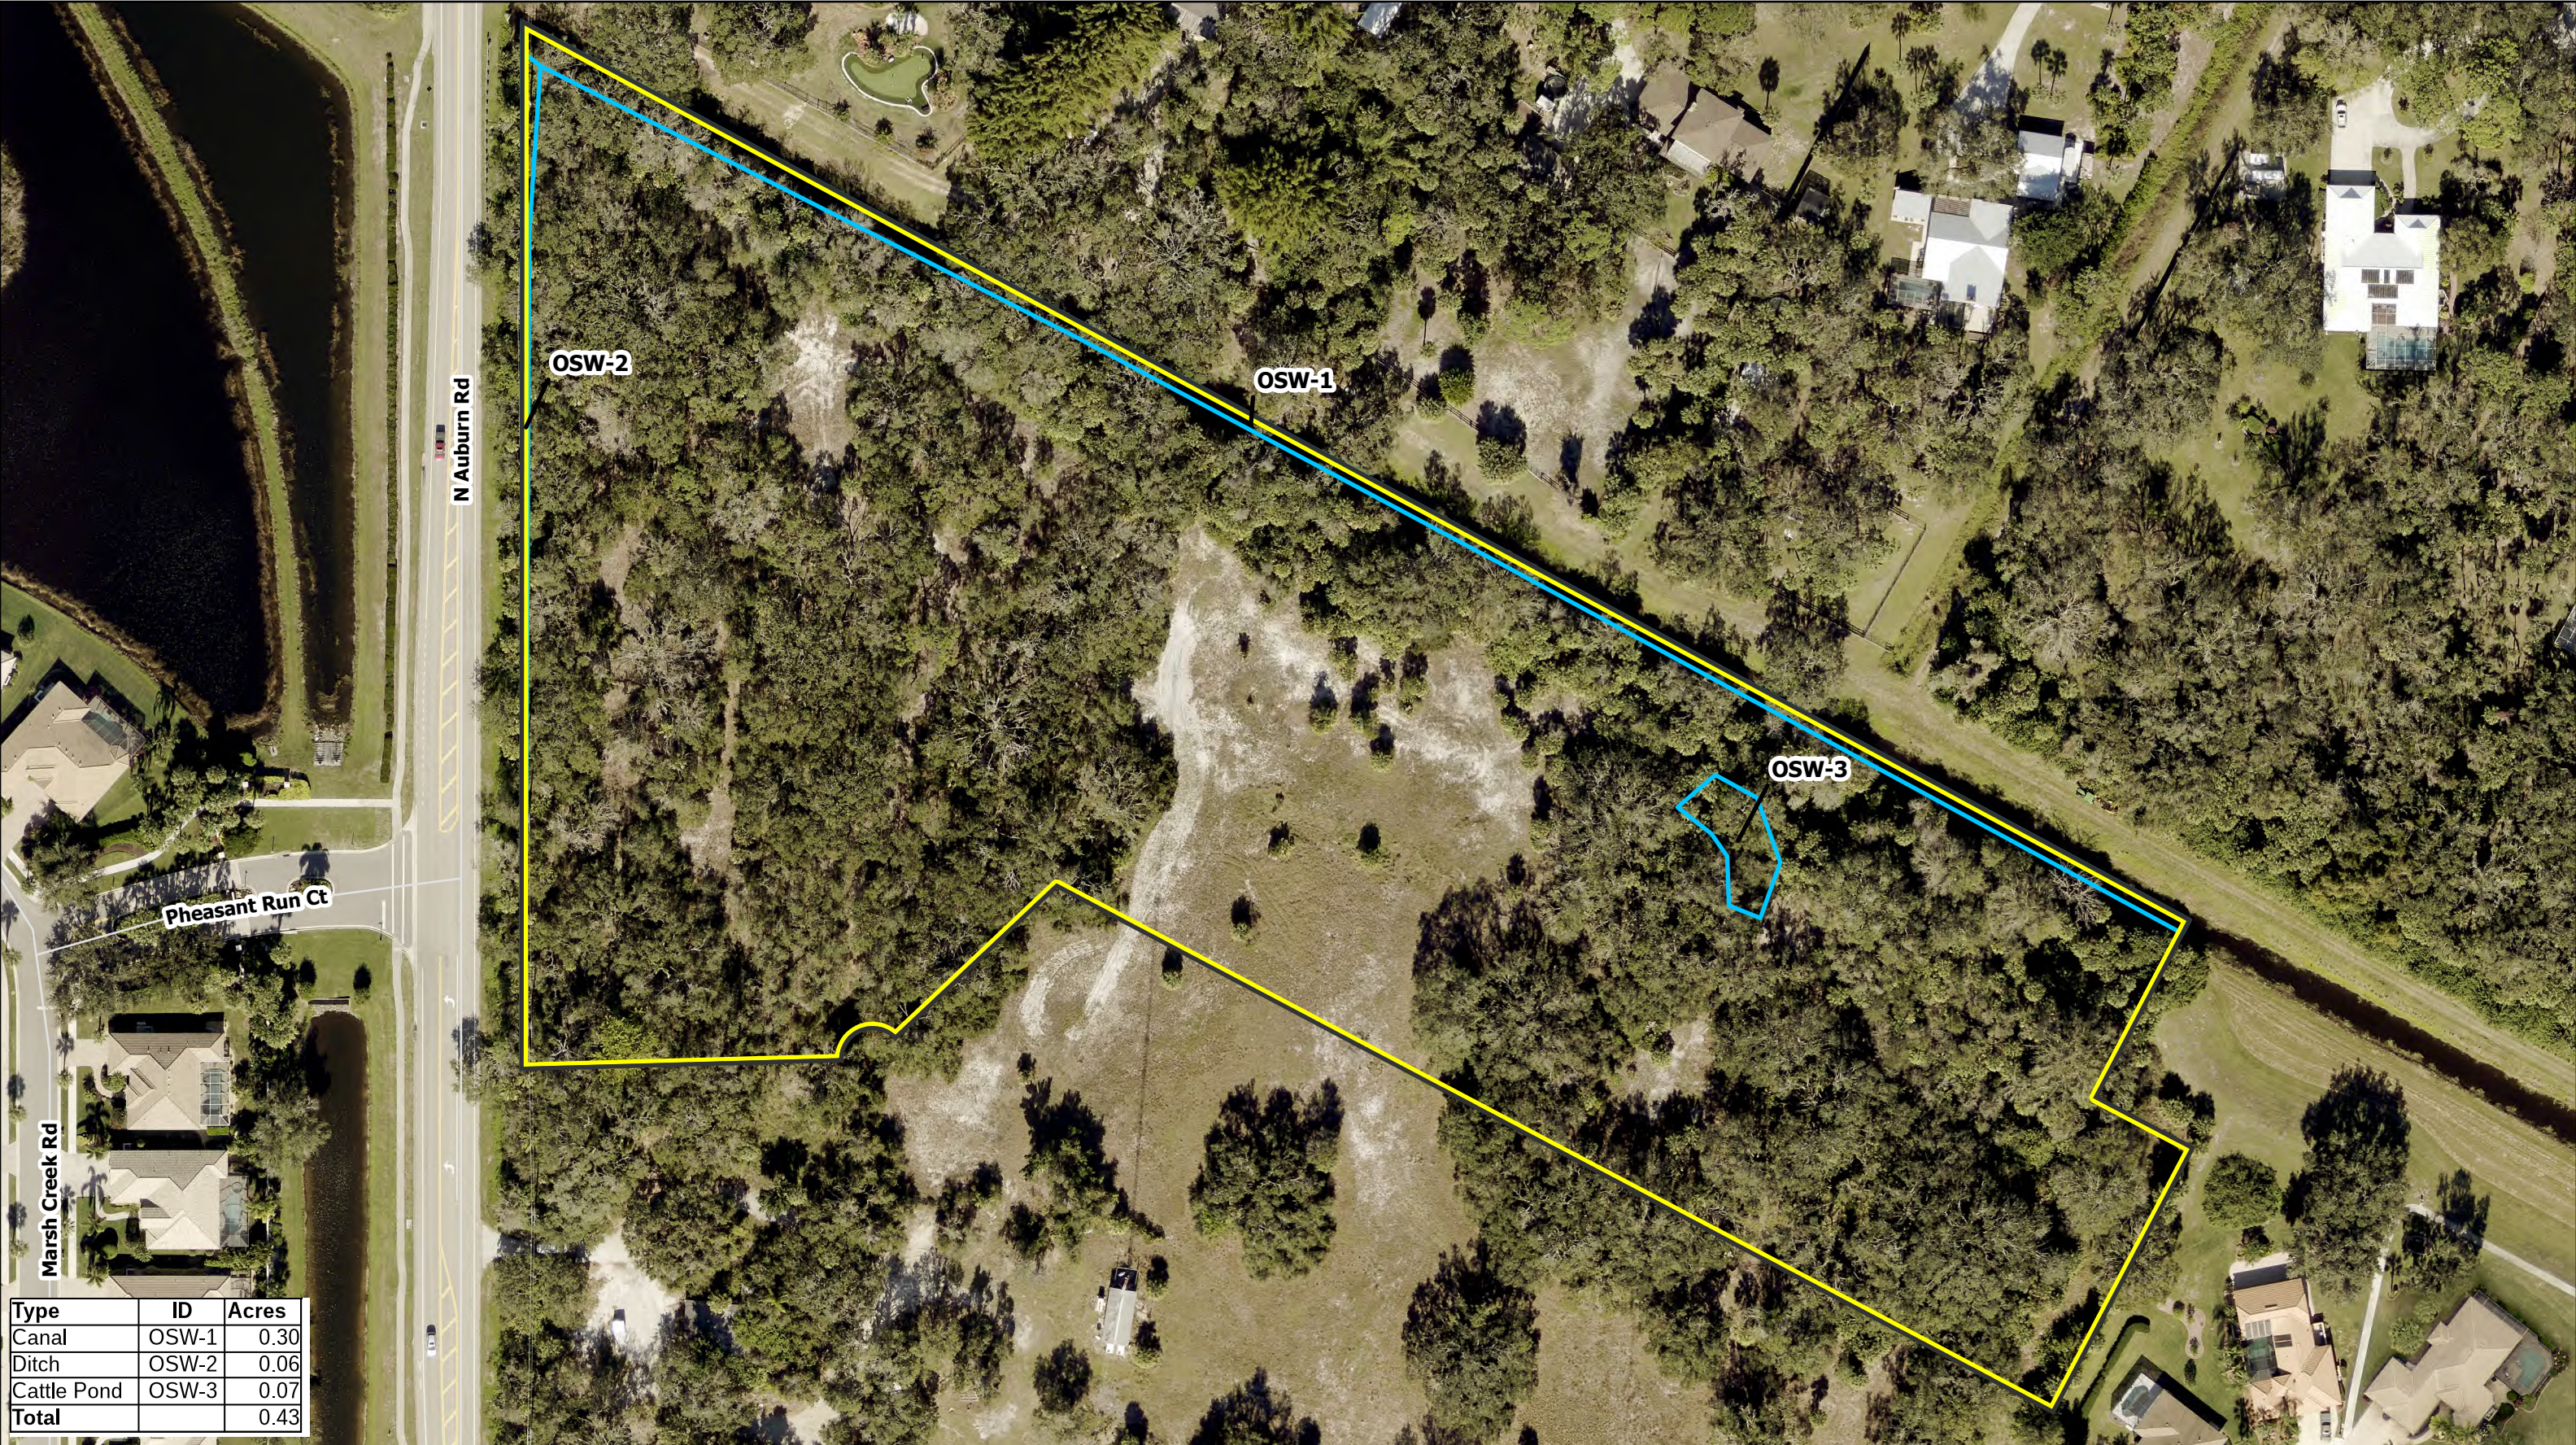
Figure 5  
Surface Waters

As shown on the Surface Water Map (Figure 5), the site contains 0.43 acres of surface waters associated with a ditch (FLUCFCS 513), the canal (FLUCFCS 511) and one small borrow pond (FLUCFCS 527). Below is a description of each surface water feature.

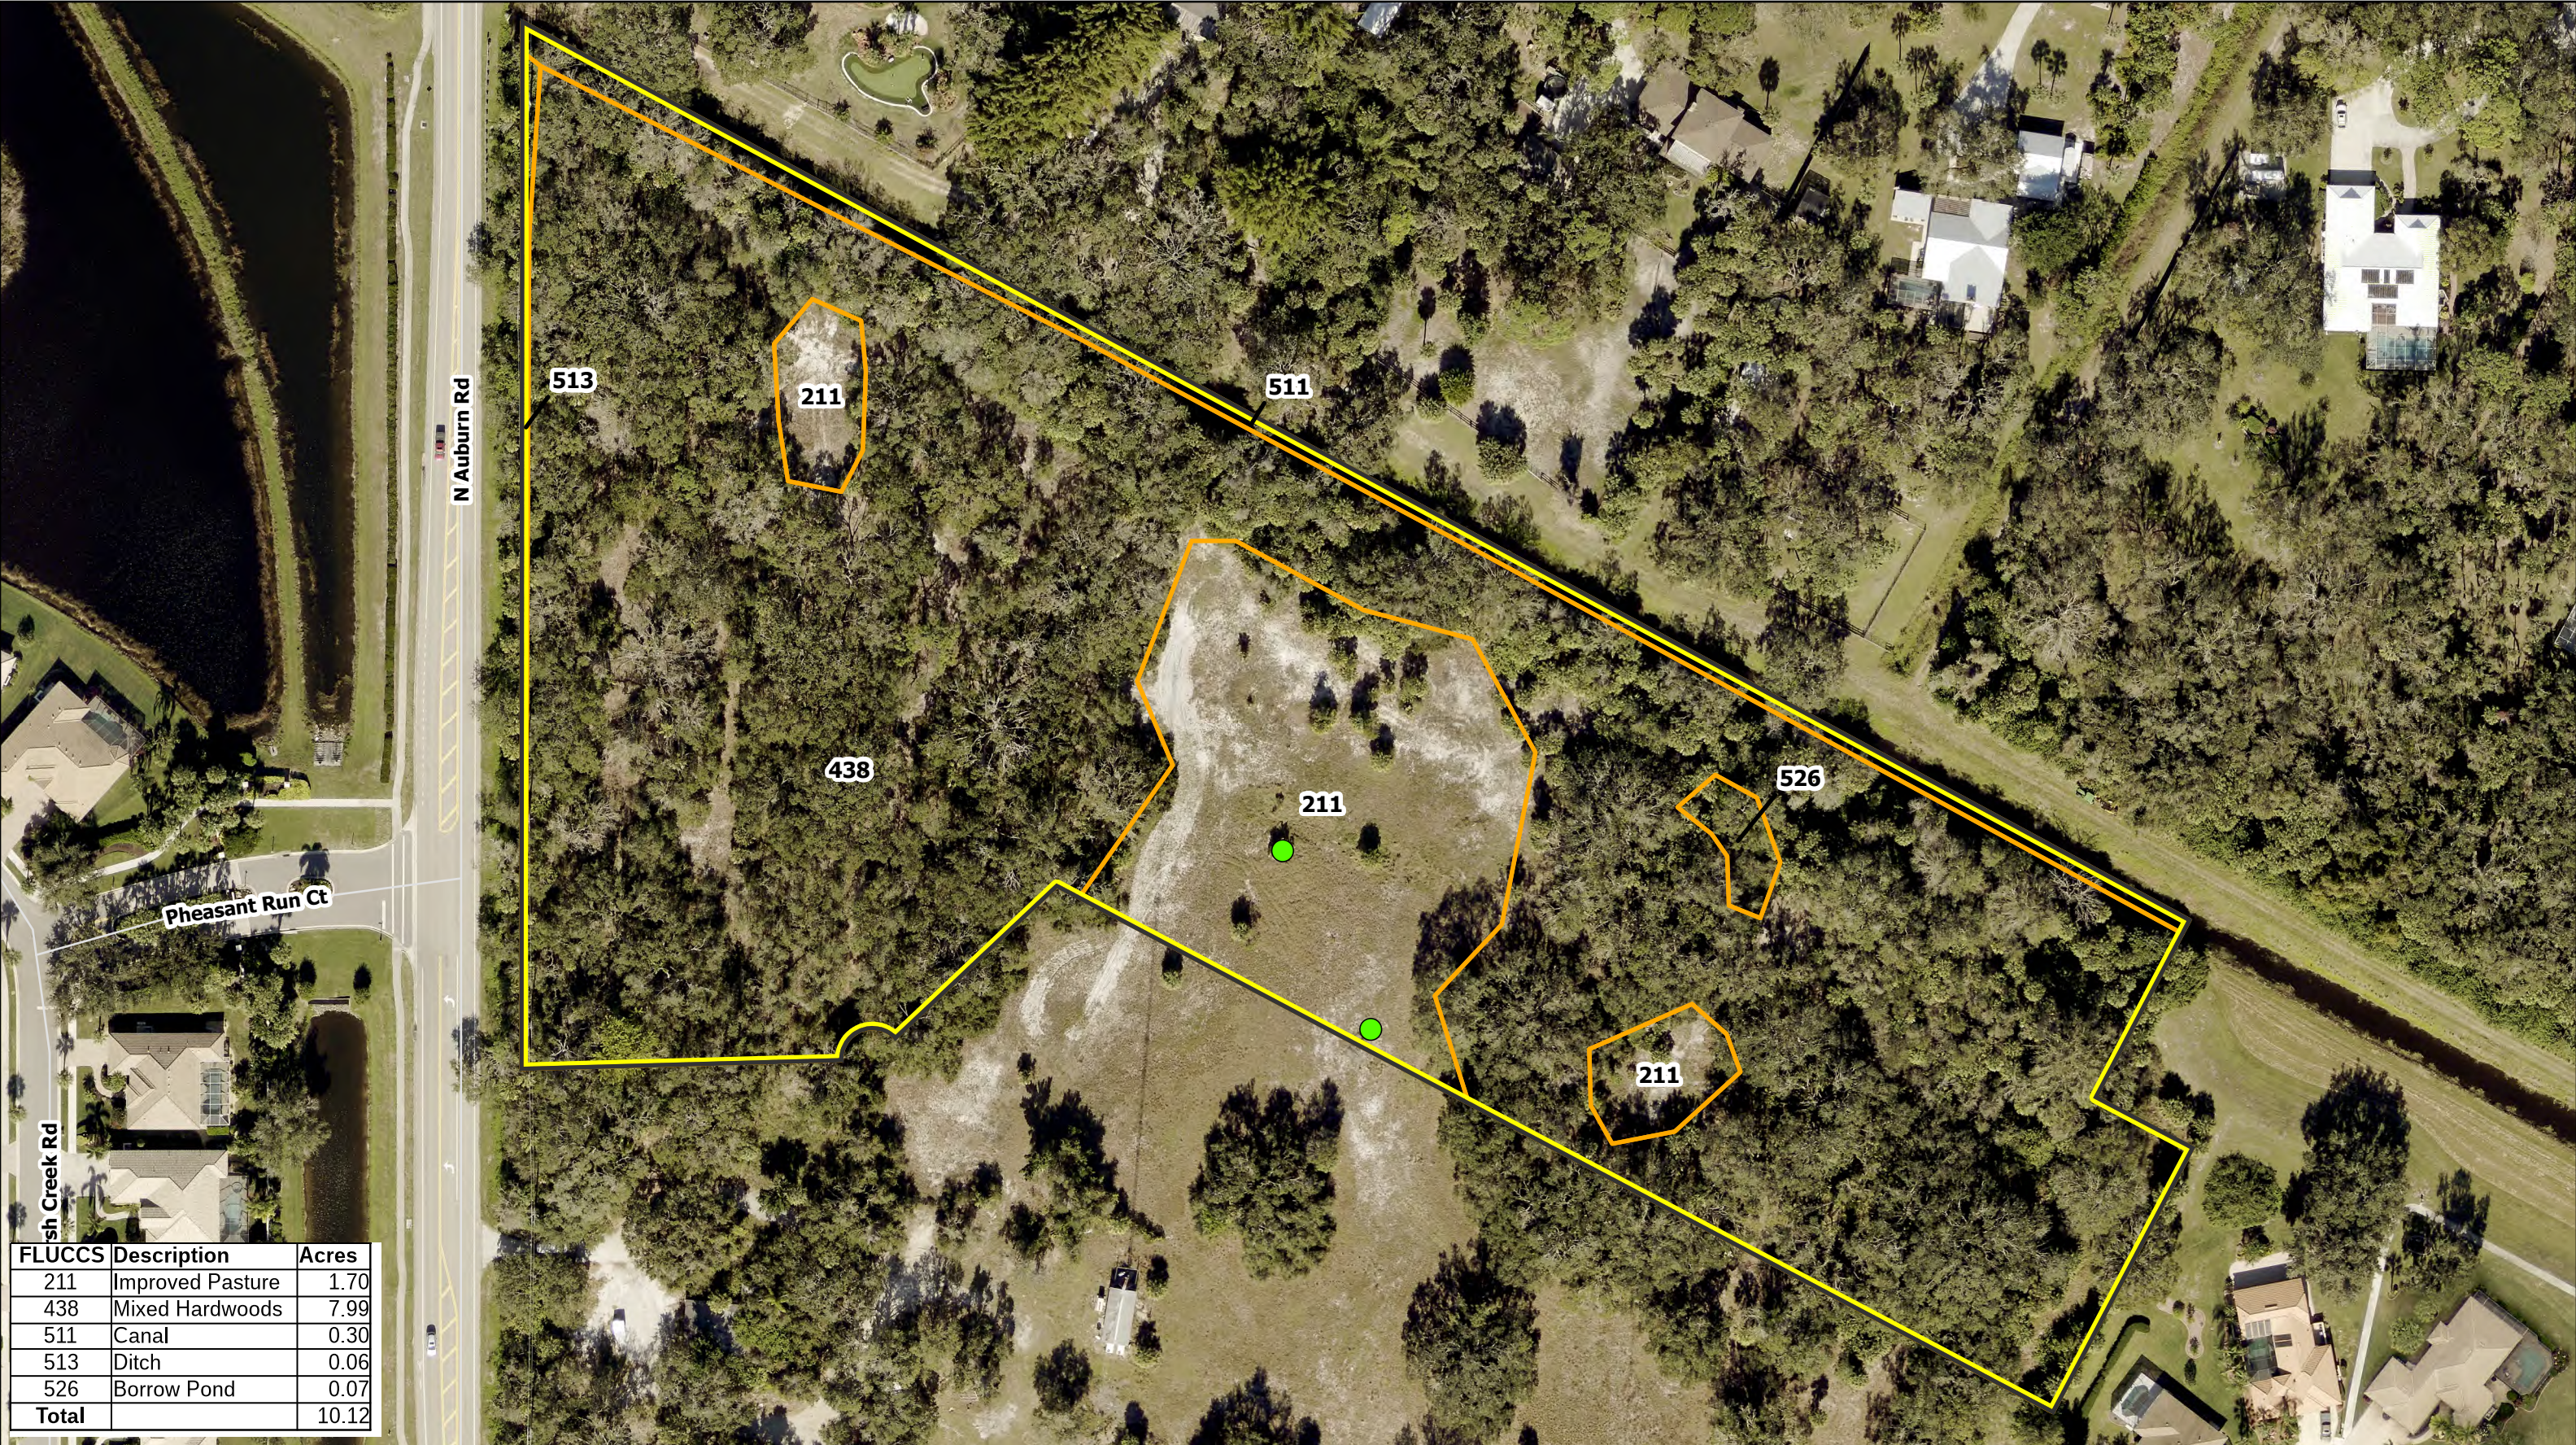
Figure 7  
Land Use/Land Cover

Gopher tortoises are listed as State-Threatened and prefer sandhills, xeric scrub habitat, palmetto prairie and pine flatwoods but can be found in other habitats and even developed areas. MONARCH observed two (2) gopher tortoise burrows during the recent survey as shown on the enclosed Land Use Map (Figure 7). A formal (100%) pre-construction survey will be required as part of future permitting efforts to comply with FWC's *Gopher Tortoise Permitting Guidelines* (Revised April 2023). The survey will be conducted within 90-days of any construction or clearing to identify any gopher tortoise burrows on the property, and a relocation permit will be required from FWC to relocate tortoises offsite (to FWC approved recipient site) prior to construction.
