2. **Exterior Lamp Post**

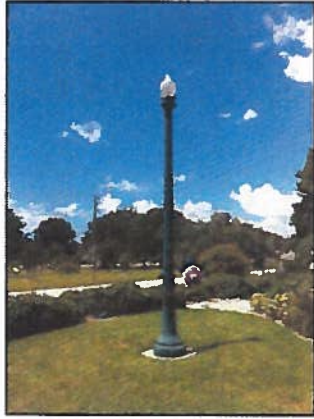
Lamp post, Image A.

The lamp post shows signs of severe corrosion which may result in structural failure. It is possible that the severity of the corrosion may be due to the interaction between mixed metals

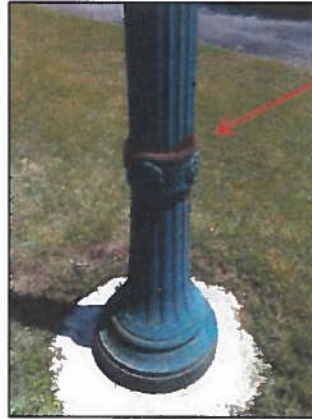
Lamp post-detail, Image B.

Severe iron corrosion
