# Facility Condition Assessment

## Campus Summary

November 02, 2017

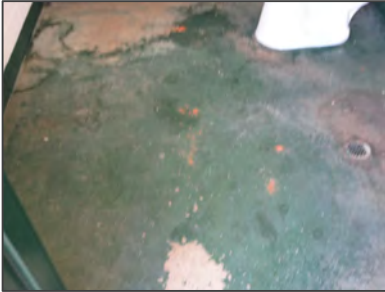
Painted flooring was observed to be in poor condition. The floor finish system was observed to have stains and worn patterns from high traffic use.

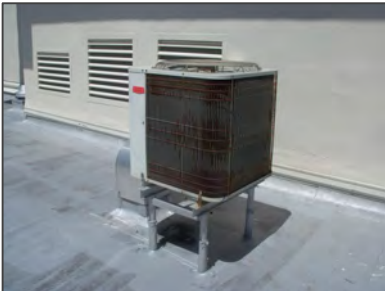
### HVAC

The split-DX units are original and use R-22 refrigerant. Insulation at exterior DX lines is deteriorated in many locations. Although the system is functioning and is well maintained, the units are near the end of average service life.

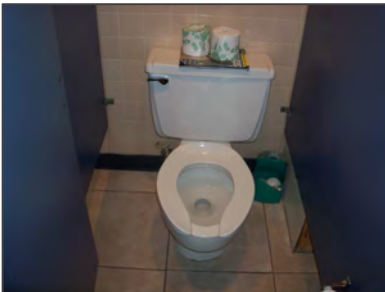
### Plumbing

Plumbing piping and sanitary sewer presumed to be original. Although functional, the systems are beyond the average service life as predicted by BOMA.

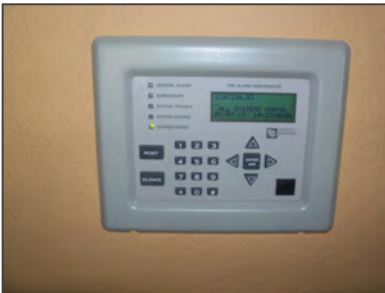
### Fire Protection

Fire alarm and detection system is comprised of pull stations. No deficiencies reported or observed.

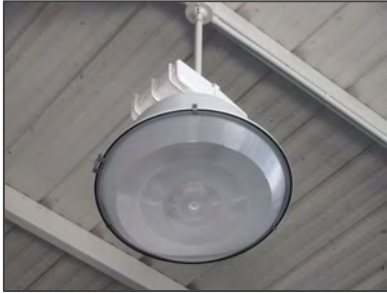
### Electrical

Lighting system is comprised of halogen lighting. Systems are in good condition. No issues observed or reported.

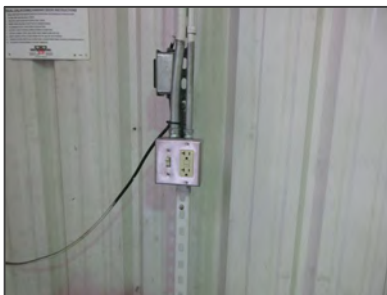
### Electrical

The light switch observed is functioning. GFCI plugs were installed in locations required by current building and safety codes.

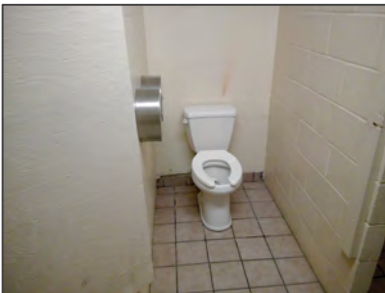
### Interiors

Floor finish system is comprised of ceramic tile. No issues observed or reported.

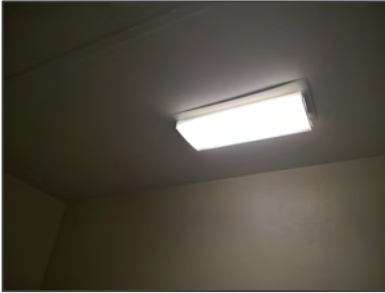
### Electrical

The lighting system was comprised of T8 bulbs, electric ballast, and a variety of diffusers. The system was observed to be in poor condition.

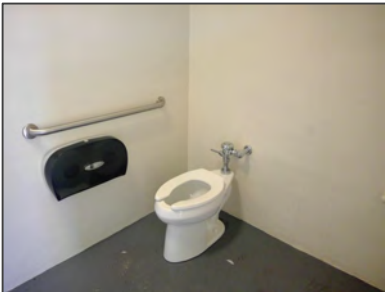
### Plumbing

Domestic water distribution is concealed and assumed to be original. It is beyond BOMA predicted service life. Sufficient testing should be performed before the system is extended. Plumbing fixtures are good condition.

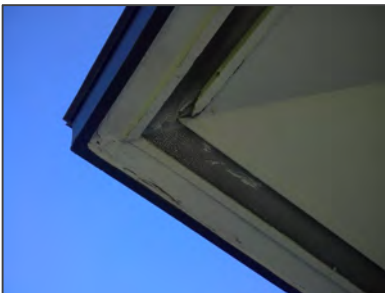
### Roofing

No leaks were observed or reported, and the asphalt shingle system was in good condition. The painted fascia board was in poor condition with peeling paint observed.

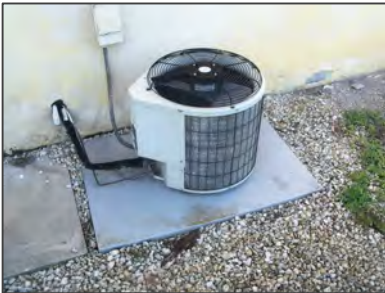
### HVAC

The split-DX units use R-22 refrigerant; insulation at exterior DX lines is deteriorated in many locations. Although the system is functioning and is well maintained, the units are near the end of average service life.

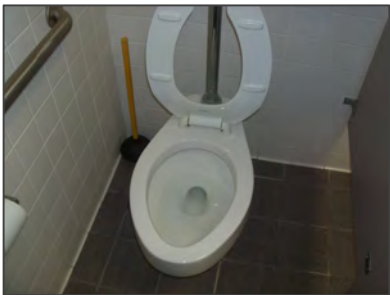
Plumbing

Piping and sanitary sewer presumed to be original. Although functional, the systems are approaching the end of their average service life as predicted by BOMA.

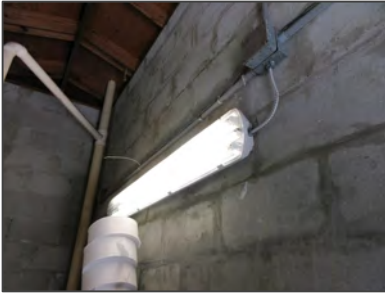
### Electrical

The lighting system was comprised of wall mounted T8 bulbs, electric ballast, and a variety of diffusers. The system was in good condition with no issues observed or reported.

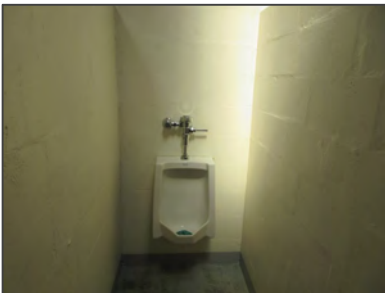
### Plumbing

All fixtures were observed to be in fair condition.

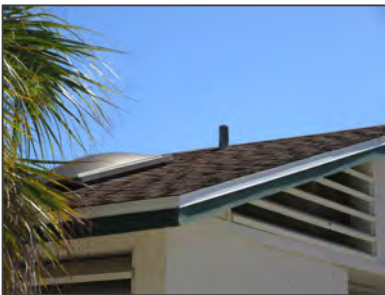
### Roofing

Asphalt roofing system was observed to be in good condition. No issues observed or reported.

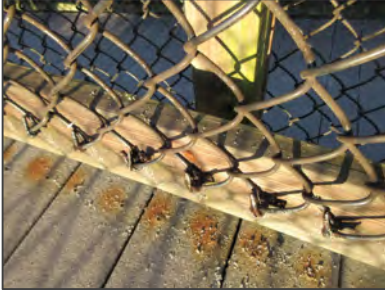
### Equipment & Furnishing

The chain link fence was found to be heavily deteriorated.

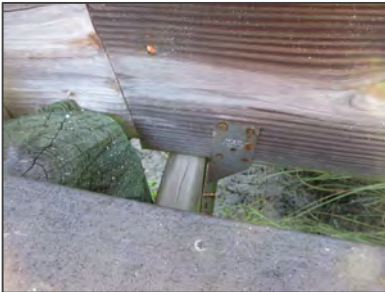
### Equipment & Furnishing

Joist hangers were found to be deteriorated, and nails were observed to be loose.

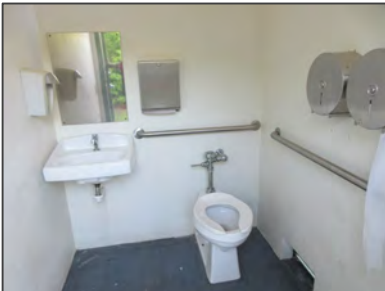
### Plumbing

All fixtures were observed to be in good condition. Manual flush valves and sink fixtures were noted.

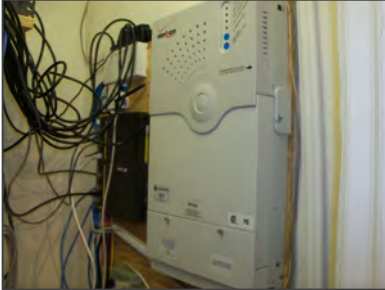
City specified need. Reports of failures or need for improvements. LAN network and Wi-Fi.

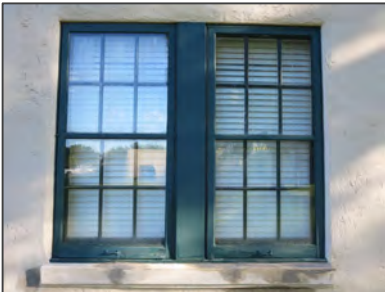
The window system consists of wood frames without insulated glass noted to be in fair condition. Useful life reduced due to condition.

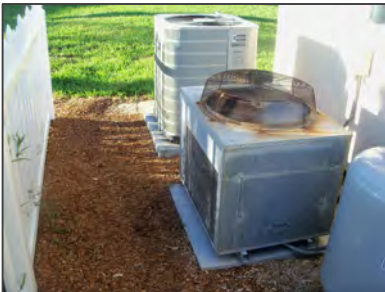
The split-DX units are original and use R-22 refrigerant. Insulation at exterior DX lines is deteriorated in many locations. Although the system is functioning and is well maintained, the units are near the end of average service life.

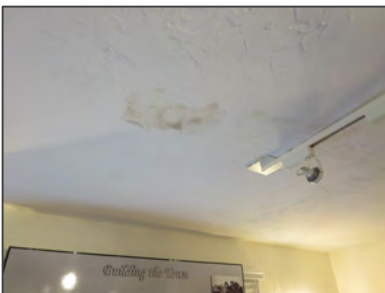
The painted hard surfaces were observed to be in poor condition. The damage could be from roof leaks or leaking HVAC water pipes. The ceiling system is expired due to condition.

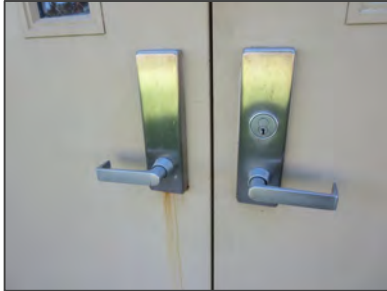
Maintenance exterior doors frames are rusted, and doors finishes are faded and chipped. Rusted door hardware could be a security issue in the future.

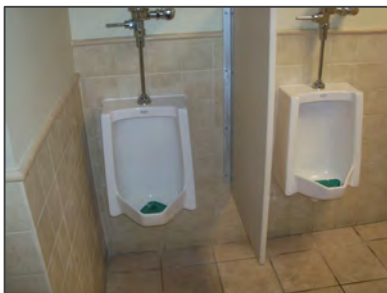
Floor Finish system is comprised of resilient and ceramic tile. System expired due to condition.

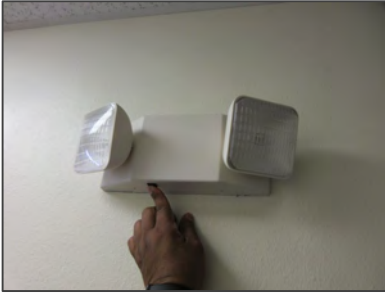
Wall mounted emergency lighting systems appears to be in poor condition. System is expired due to age. Troffer light fixtures in the office area did have an integrated backup system in good condition.

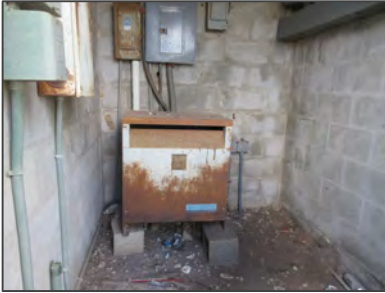
The electrical system appears to be mostly original. Although functional, the electrical system is beyond the average service life as predicted by BOMA.

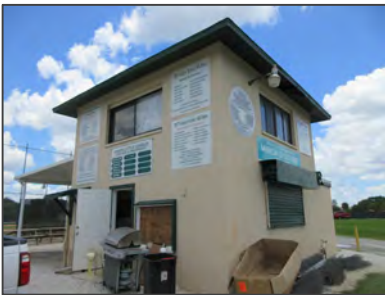
Exterior wall finishes were comprised of stucco with painted trim. Systems were observed to be in fair condition.

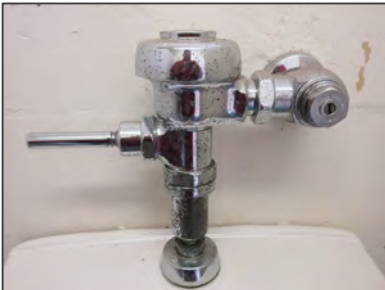
Domestic water and sanitary sewer piping is original to the building and beyond BOMA predicted service life. Fixtures are in fair to poor condition.

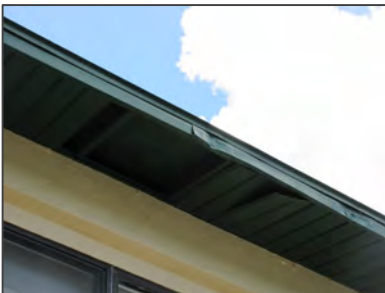
The soffit and fascia were found to be dented, missing, and damaged.

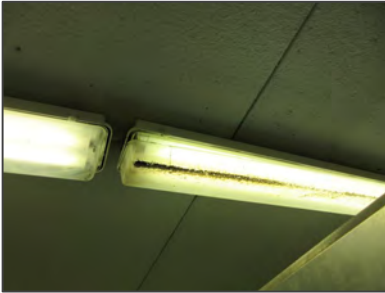
Lighting system is comprised of super T8 fluorescent lamps. Fixtures were found to be in poor condition. Bugs and other debris were observed in light diffusers.

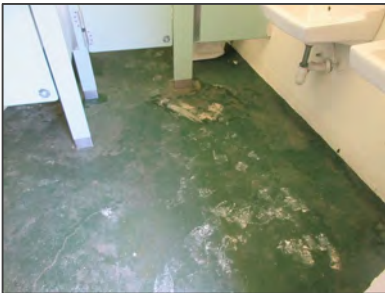
The floor finish system was observed to have stains and show heavy wear from high traffic. System expired due to condition.

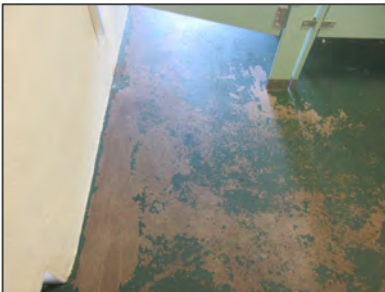
The floor finish system was observed to have stains and show heavy wear from high traffic. System expired due to condition.

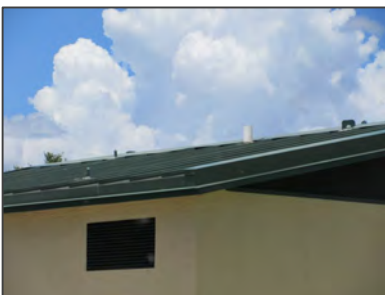
The standing seam roof was found to be in overall good condition. No issues observed or reported.

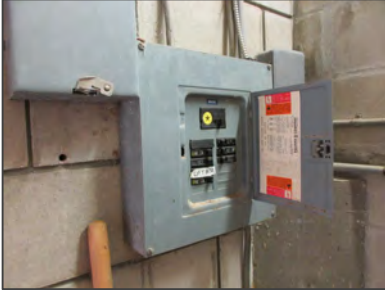
Electrical service and distribution Panel system appears to be in poor condition and is missing breakers. System is expired due to age and condition.

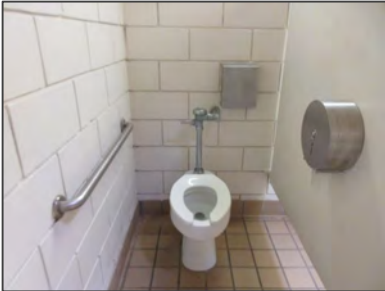
All fixtures were observed to be in good condition. Manual flush valves and sink fixtures were noted.

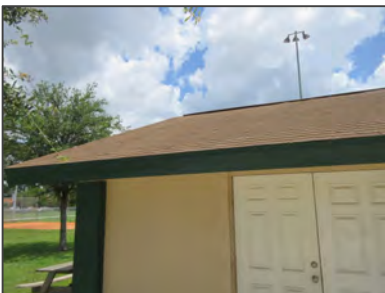
The roofing system is comprised of asphalt shingle roofing. No leaks were observed or reported, and system was in good condition.

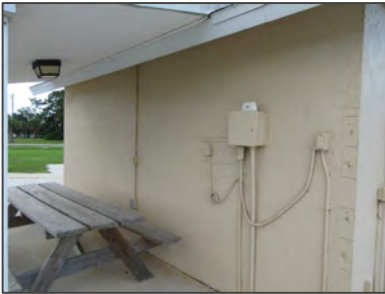
The painted stucco finish was found to be in fair condition. No issues observed or reported.

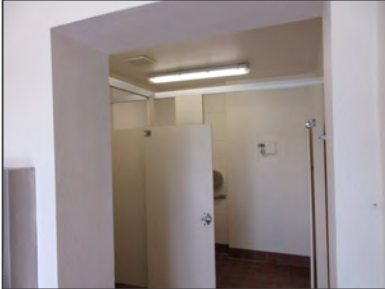
Wooden partitions were noted with damaged hardware and mounting brackets. Repairs may be adequate, but a replacement should be considered soon.

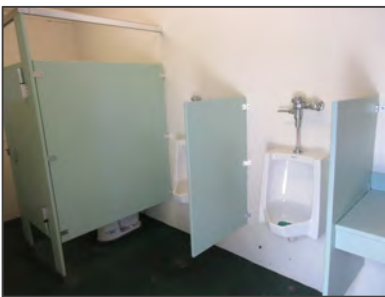
The toilet partitions were found to be in good condition. No issues observed or reported.

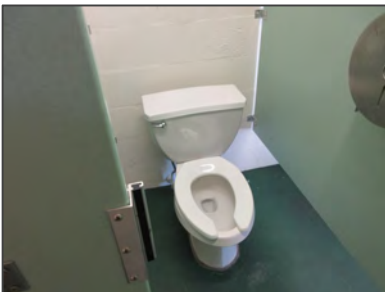
All fixtures were observed to be in good condition. Manual flush valves and sink fixtures were noted.

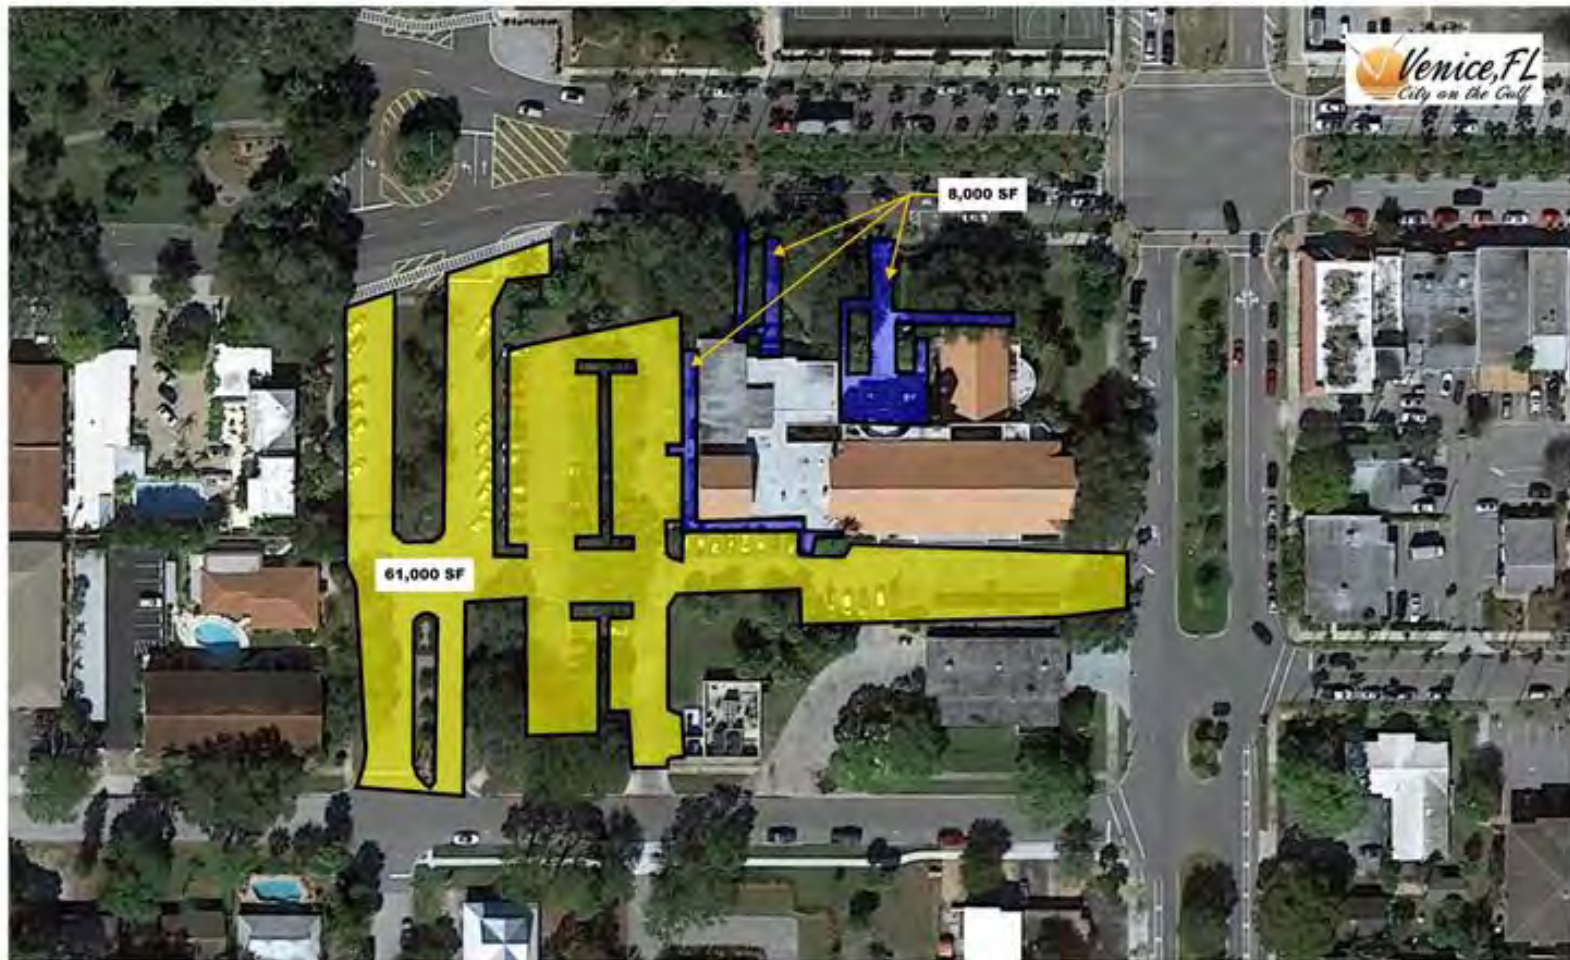
## City Hall

- The concrete sidewalks were in overall good condition; however, replacement of the sealant in the expansion joints as part of routine maintenance would extend their overall life
- The asphalt pavements were generally in good condition; however, crack filling, seal coating, and restriping would extend the overall life of the pavement.

| Asset Description | Corrective Action | Notes | Current Needs |
|---|---|---|---|
| Pedestrian Pavements | Replace Caulking in Concrete Pavements | 8,000 SF @ \$0.65 per SF | \$5,200 |
| Vehicular Pavements | Crack Fill, Seal Coat, and Restripe Asphalt Pavements | 61,000 SF @ \$1.20 per SF | \$73,200 |

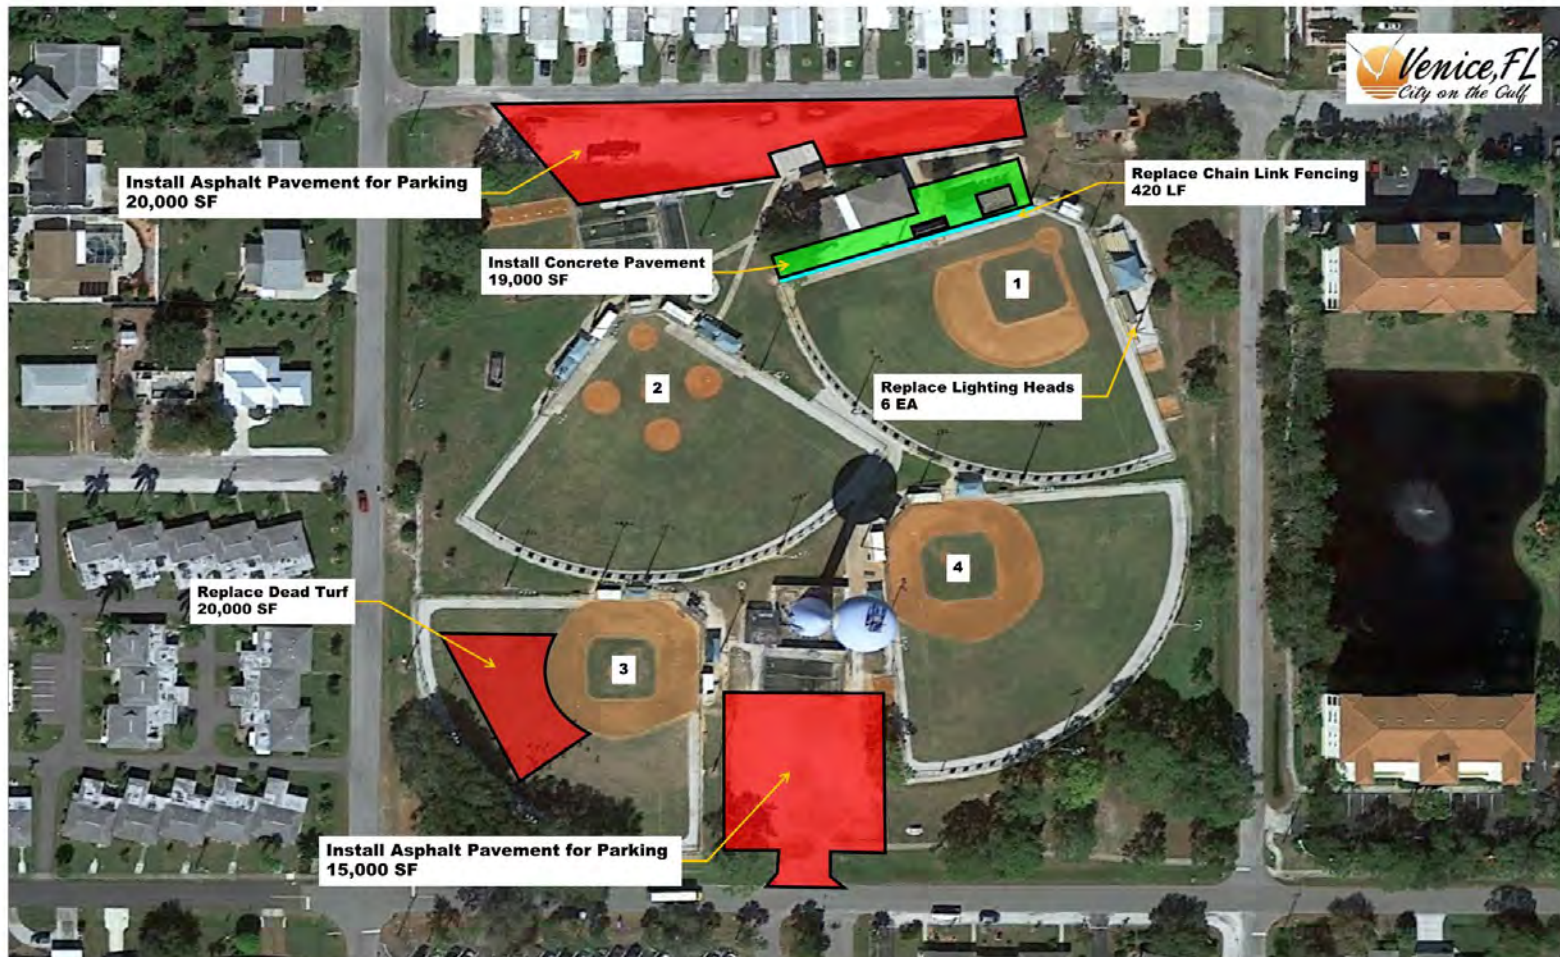
## Chuck Reiter Park

- New concrete is needed to help correct existing drainage issues which are causing the fencing to deteriorate due to standing water.
- The existing gravels parking lots need to be resurfaced with asphalt.

- The ballfield site lighting was comprised of Sportsliter Solutions lighting which was observed to be in good condition. There was rust and other signs of weather deterioration present on the lighting poles, control boxes, and fixtures. It was reported by the field personnel that the lighting on field #1 does not meet the little league field standards and needs to be replaced.

- Sports fields 1,2, and 4 were in good condition with no major deficiencies observed or reported. Field surface grading appeared to be good with no evidence of drainage problems or standing water. Sports field 3 contained a large area of dead turf which needs to be replaced.

- The electronic scoreboards were observed to be in fair condition. Scoreboards were faded and showed signs of age and/or weather deterioration.
- The aluminum bleachers were observed to be in good condition with no major issues observed. Dugout benches were observed to be in good structural condition; however, they need to be repainted as part of routine maintenance.

- The fencing was chain link which ranged in height from 5-6 feet tall. The fencing and gates were observed to be in good condition with no major issues observed. Minor rusting was observed on some fencing, fence posts, and gates. The fencing along the first base side of sports field 1 was badly rusted and deteriorated. Reports of prolonged exposure to standing water due to current

drainage problems has greatly decreased the useful life of this fencing. Recommend replacement.

- The back stops and protective netting was comprised of chain link and nylon netting which were observed to be in good condition. Chain link back stops ranged in heights from 10 - 20 FT tall and there were no major issues observed. Minor rusting was observed throughout.

| Asset Description | Corrective Action | Notes | Current Needs |
|---|---|---|---|
| Site Development | Replace Site Lighting at Field #1 | 1 EA @ \$78,750 | \$78,750 |
| Site Development | Replace Sports Field Turf | 20,000 SF @ \$0.35 SF | \$7,000 |
| Site Development | Replace Chain Link Fencing | 420 LF @ \$20 LF | \$8,400 |
| Site Development | Repaint Dugout Benches | 700 SF @ \$3.00 SF | \$2,100 |

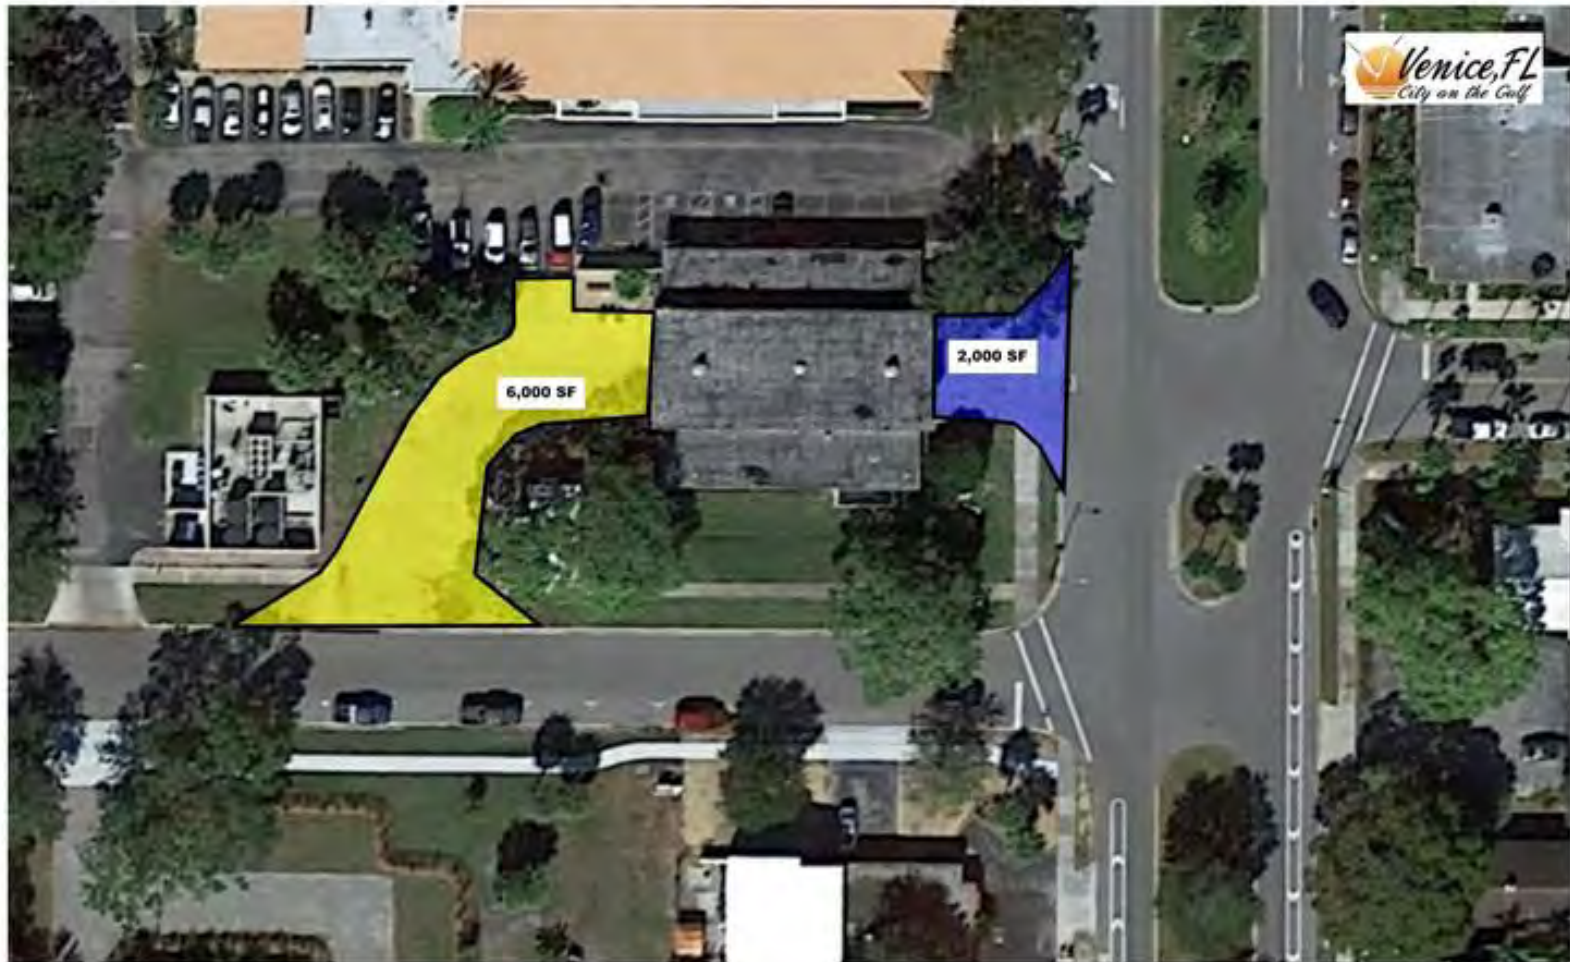
## Fire Station 51

- The concrete sidewalks were in overall good condition; however, replacement of the sealant in the expansion joints as part of routine maintenance would extend their overall life
- The asphalt pavements were generally in good condition; however, crack filling, seal coating, and restriping would extend the overall life of the pavement.

| Asset Description | Corrective Action | Notes | Current Needs |
|---|---|---|---|
| Pedestrian Pavements | Replace Caulking in Concrete Pavements | 2,000 SF @ \$0.65 per SF | \$1,300 |
| Vehicular Pavements | Crack Fill, Seal Coat, and Restripe Asphalt Pavements | 6,000 SF @ \$1.20 per SF | \$7,200 |

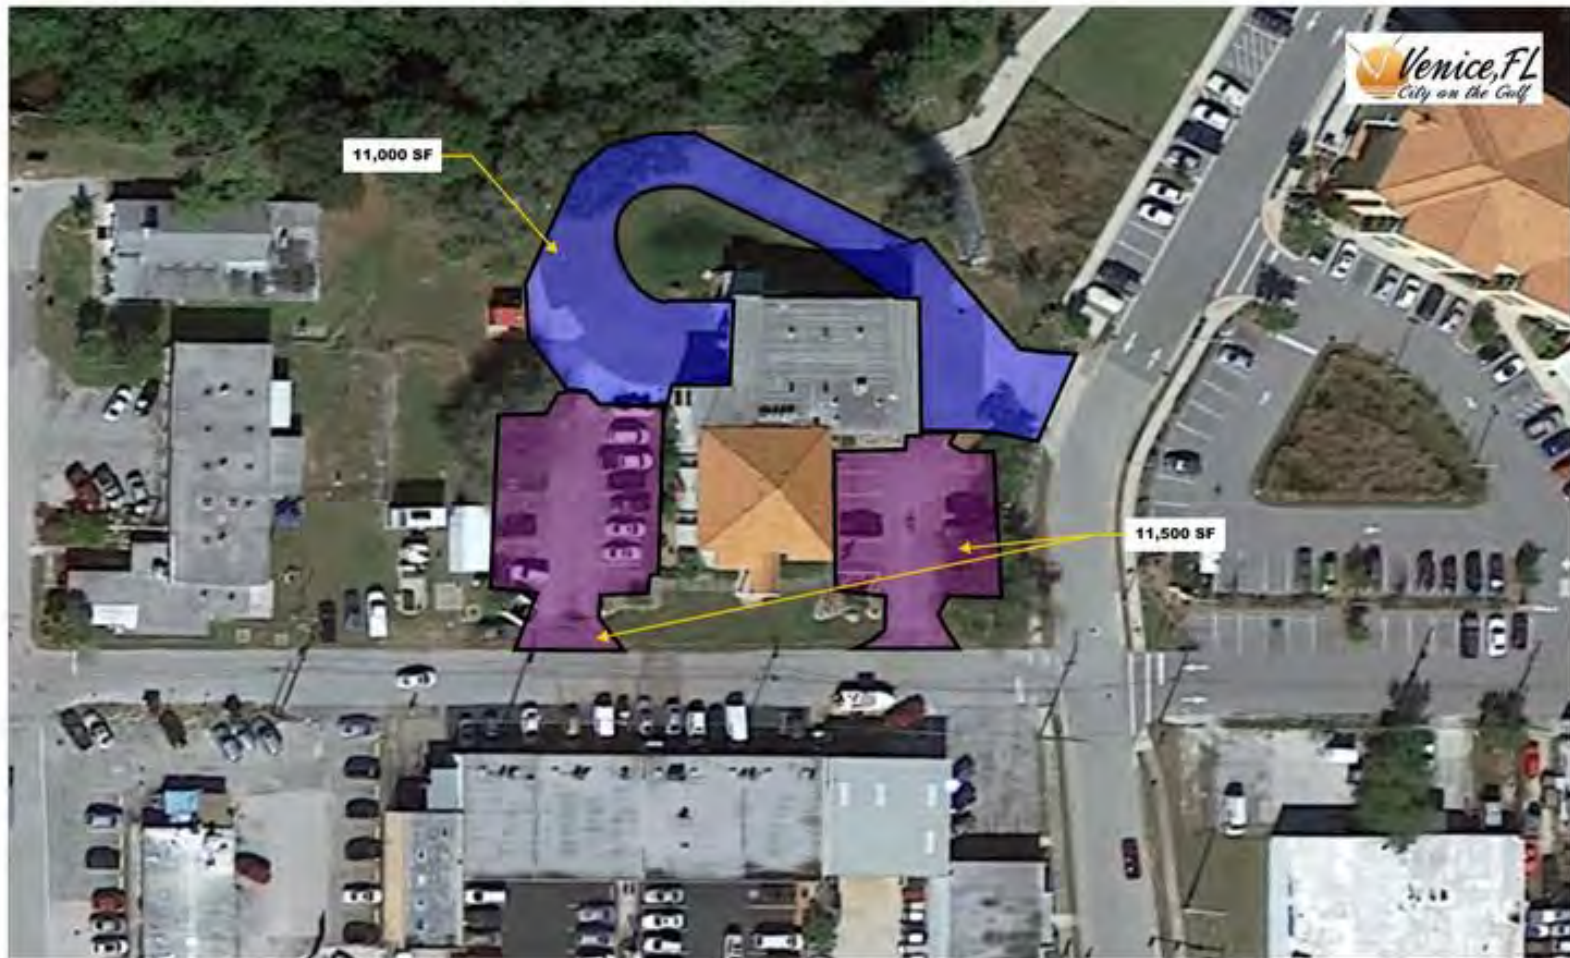
## Fire Station 52

- The concrete sidewalks were in overall good condition; however, replacement of the sealant in the expansion joints as part of routine maintenance would extend their overall life
- The asphalt pavements were in poor condition and need to be resurfaced.

| Asset Description | Corrective Action | Notes | Current Needs |
|---|---|---|---|
| Pedestrian Pavements | Replace Caulking in Concrete Pavements | 11,000 SF @ \$0.65 per SF | \$7,150 |
| Vehicular Pavements | Resurface Asphalt Pavements | 11,500 SF @ \$3.50 per SF | \$40,250 |
