Facility Condition Assessment

Campus Summary

November 02, 2017

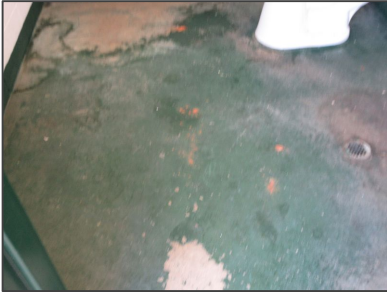
Interiors

Painted flooring was observed to be in poor condition. The floor finish system was observed to have stains and worn patterns from high traffic use.

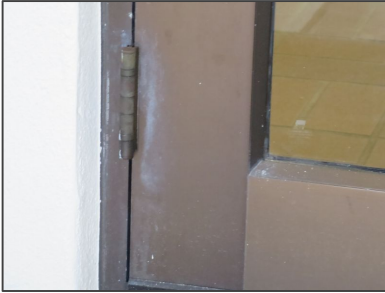
Exterior Enclosure

Exterior doors frames and finishes are faded and chipped. Deteriorated door hardware could be a security issue in the future.

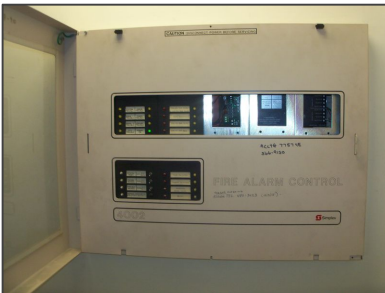
Fire Protection

Fire alarm and detection system is expired due to age and condition.

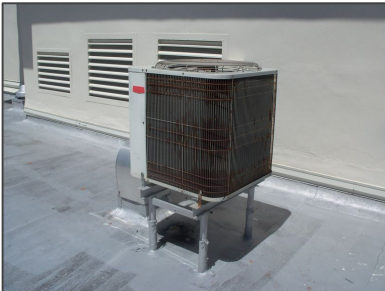
HVAC

The split-DX units are original and use R-22 refrigerant. Insulation at exterior DX lines is deteriorated in many locations. Although the system is functioning and is well maintained, the units are near the end of average service life.

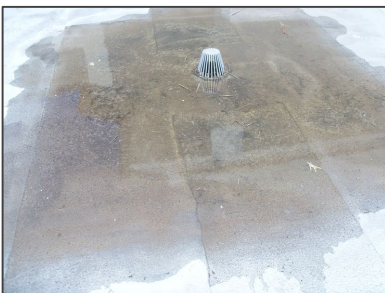
Roofing

Built-up roof covering was in poor condition. Tears and holes were observed. The fabric is worn, and leaks will become more frequent. Rain water drainage was observed to be inadequate due to roof slope.

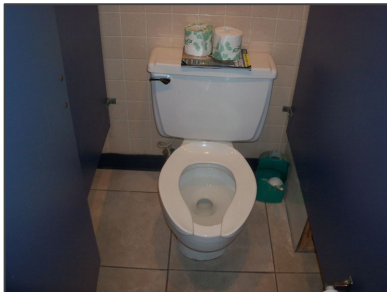
Plumbing piping and sanitary sewer presumed to be original. Although functional, the systems are beyond the average service life as predicted by BOMA.

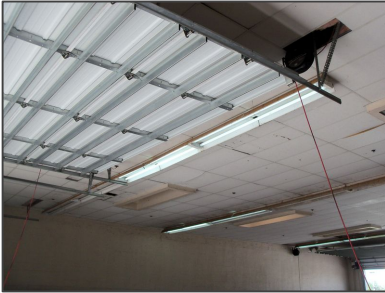
Electrical

The lighting system appears to be mostly original. Although functional, the lighting system is beyond the average service life as predicted by BOMA.

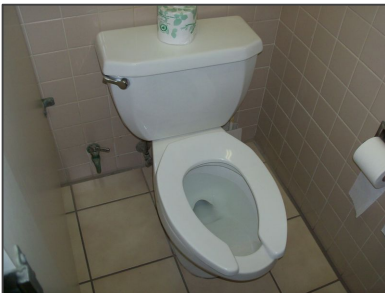
Plumbing piping and sanitary sewer presumed to be original. Although functional, the systems are beyond the average service life as predicted by BOMA.

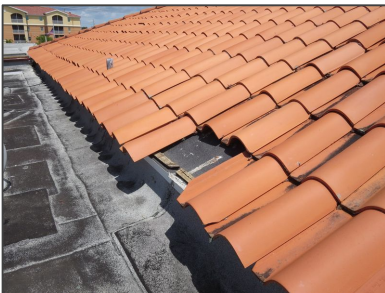
Roofing

The built-up roof system was observed to have tears and holes. A section of roof area is covered with ceramic tile which was also in poor condition.

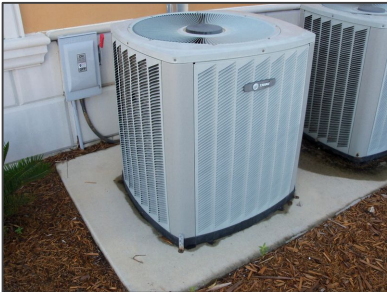
HVAC units utilize R-22 refrigerant. In 2020 R-22 refrigerant will be limited and servicing existing equipment will need to use recycled refrigerant.

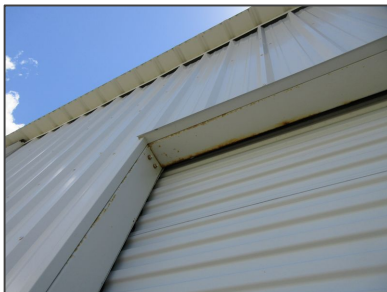
Exterior Enclosure

Roll up and side entrance doors are in fair condition. Peeling and chipping paint on wood trim and metal frame is showing signs of rust.

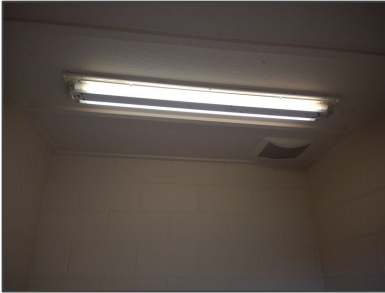
Electrical

Lighting is inadequate for the space and past its useful service life.

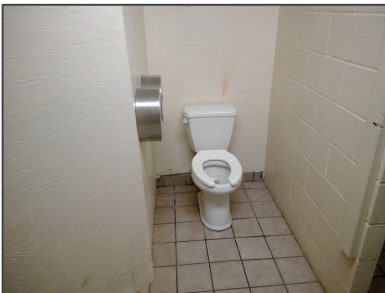
Interiors

Floor finish system is comprised of ceramic tile. No issues observed or reported.

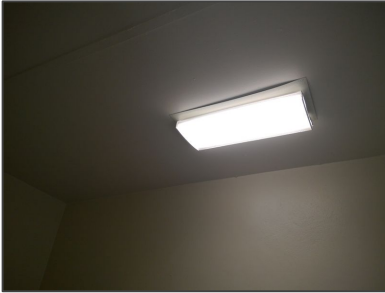
Electrical

The lighting system was comprised of T8 bulbs, electric ballast, and a variety of diffusers. The system was observed to be in poor condition.

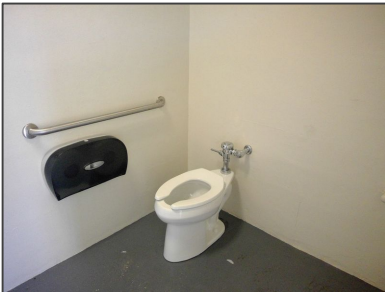
Domestic water distribution is concealed and assumed to be original. It is beyond BOMA predicted service life. Sufficient testing should be performed before the system is extended. Plumbing fixtures are good condition.

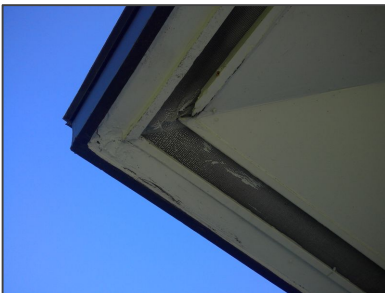
Roofing

No leaks were observed or reported, and the asphalt shingle system was in good condition. The painted fascia board was in poor condition with peeling paint observed.

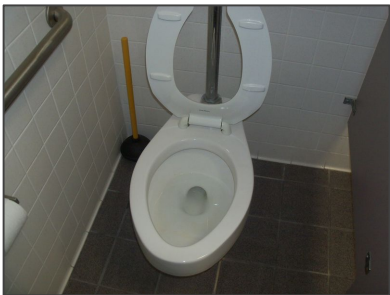
Plumbing

Piping and sanitary sewer presumed to be original. Although functional, the systems are approaching the end of their average service life as predicted by BOMA.

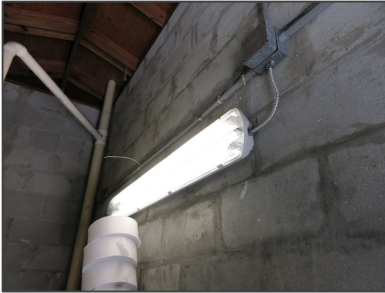
Electrical

The lighting system was comprised of wall mounted T8 bulbs, electric ballast, and a variety of diffusers. The system was in good condition with no issues observed or reported.

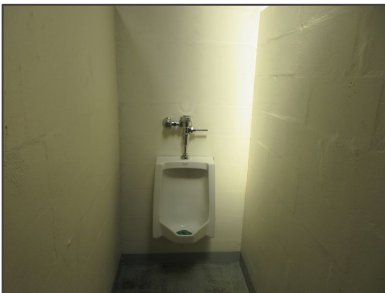
Plumbing

All fixtures were observed to be in fair condition.

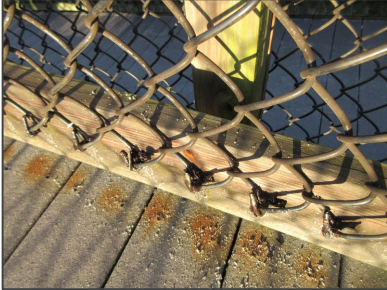
Equipment & Furnishing

The chain link fence was found to be heavily deteriorated.

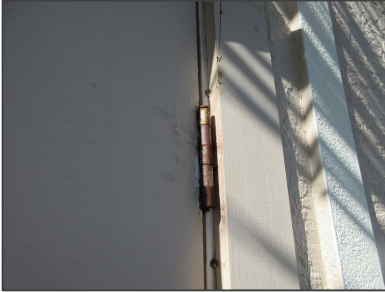
Exterior Enclosure

Maintenance exterior doors frames are rusted, and doors finishes are faded and chipped. Rusted door hardware could be a security issue in the future.

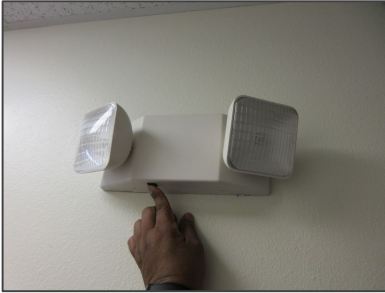
Electrical

Wall mounted emergency lighting systems appears to be in poor condition. System is expired due to age. Troffer light fixtures in the office area did have an integrated backup system in good condition.

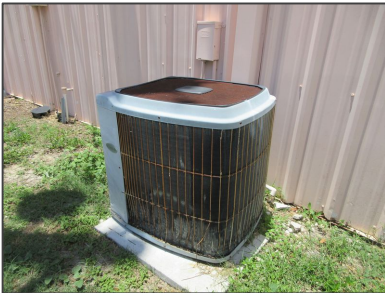
HVAC

The split-DX units are original and use R-22 refrigerant. Insulation at exterior DX lines is deteriorated in many locations. Although the system is functioning and is well maintained, the units are near the end of average service life.

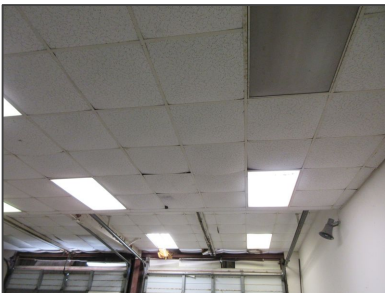
Interiors

Acoustical ceiling tiles are sagging in a few areas and replacement may be needed soon. Life cycle reduced due to condition.

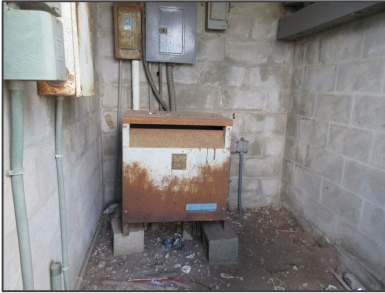
Electrical

The electrical system appears to be mostly original. Although functional, the electrical system is beyond the average service life as predicted by BOMA.

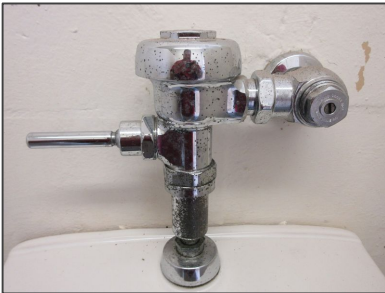
Plumbing

Domestic water and sanitary sewer piping is original to the building and beyond BOMA predicted service life. Fixtures are in fair to poor condition.

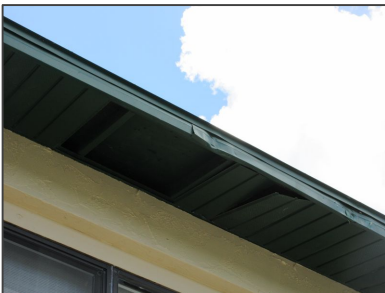
Roofing

The soffit and fascia were found to be dented, missing, and damaged.

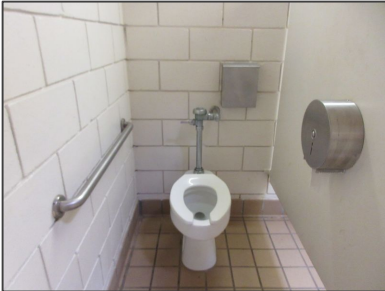
Plumbing

All fixtures were observed to be in good condition. Manual flush valves and sink fixtures were noted.

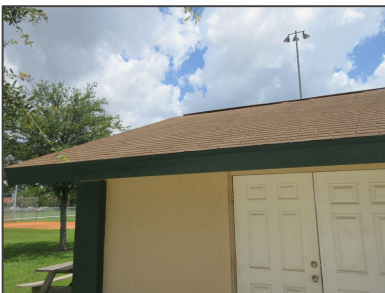
Roofing

The roofing system is comprised of asphalt shingle roofing. No leaks were observed or reported, and system was in good condition.

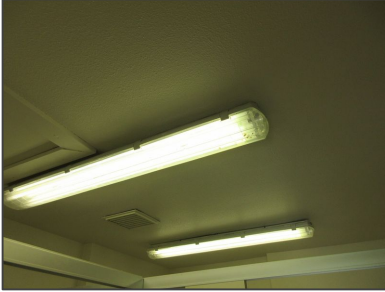
Electrical

Lighting system is comprised of super T8 fluorescent lamps. Systems are in good condition. No issues observed or reported.

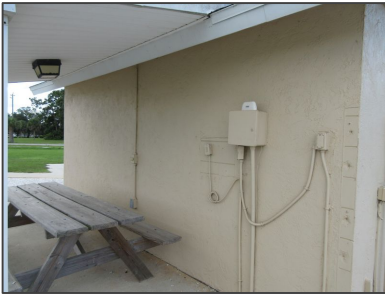
Exterior Enclosure

The painted stucco finish was found to be in fair condition. No issues observed or reported.

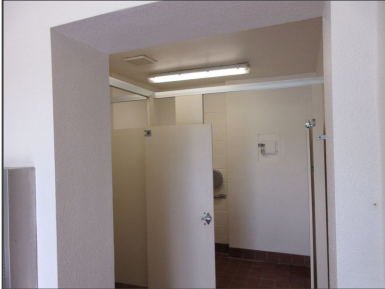
Interior Construction

Wooden partitions were noted with damaged hardware and mounting brackets. Repairs may be adequate, but a replacement should be considered soon.

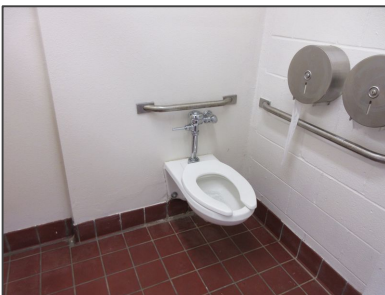
Plumbing

All fixtures were observed to be in good condition. Manual flush valves and sink fixtures were noted.

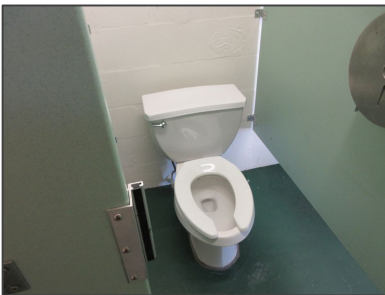
Plumbing

All fixtures were observed to be in good condition. Manual flush valves and sink fixtures were noted.

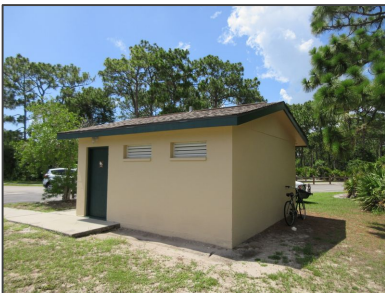
Roofing

No leaks were observed or reported, and the asphalt shingle roofing system was in good condition. The painted fascia board was in poor condition with peeling paint observed.

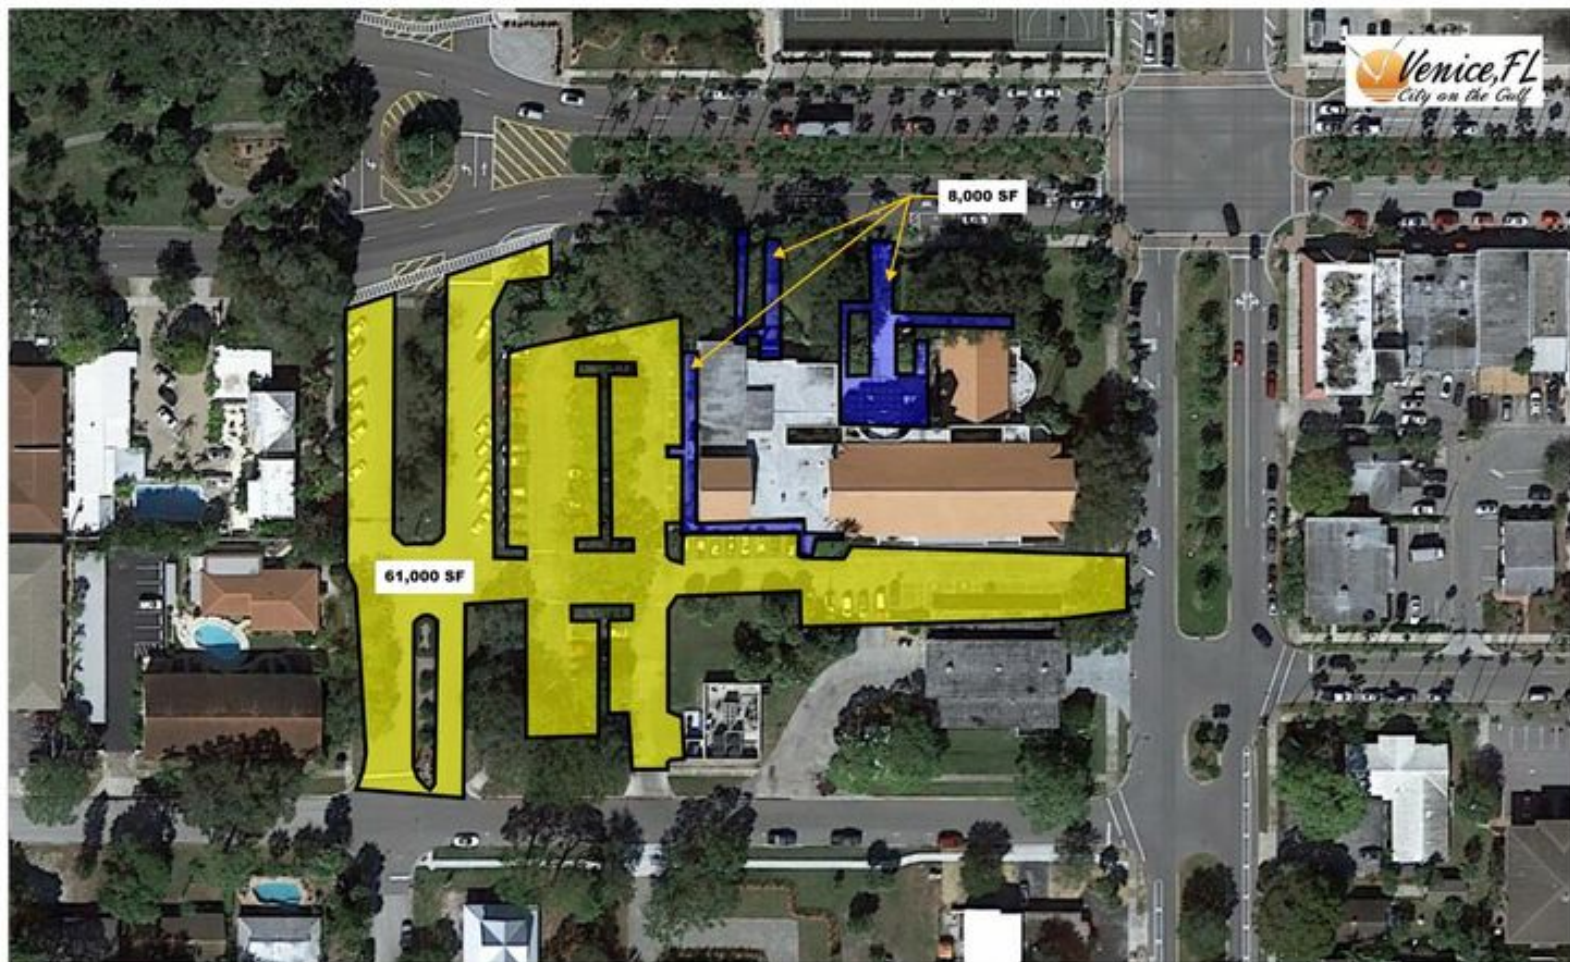
City Hall

- The concrete sidewalks were in overall good condition; however, replacement of the sealant in the expansion joints as part of routine maintenance would extend their overall life
- The asphalt pavements were generally in good condition; however, crack filling, seal coating, and restriping would extend the overall life of the pavement.

Asset Description	Corrective Action	Notes	Current Needs
Pedestrian Pavements	Replace Caulking in Concrete Pavements	8,000 SF @ \$0.65 per SF	\$5,200
Vehicular Pavements	Crack Fill, Seal Coat, and Restripe Asphalt Pavements	61,000 SF @ \$1.20 per SF	\$73,200
Total Current Needs			\$78,400

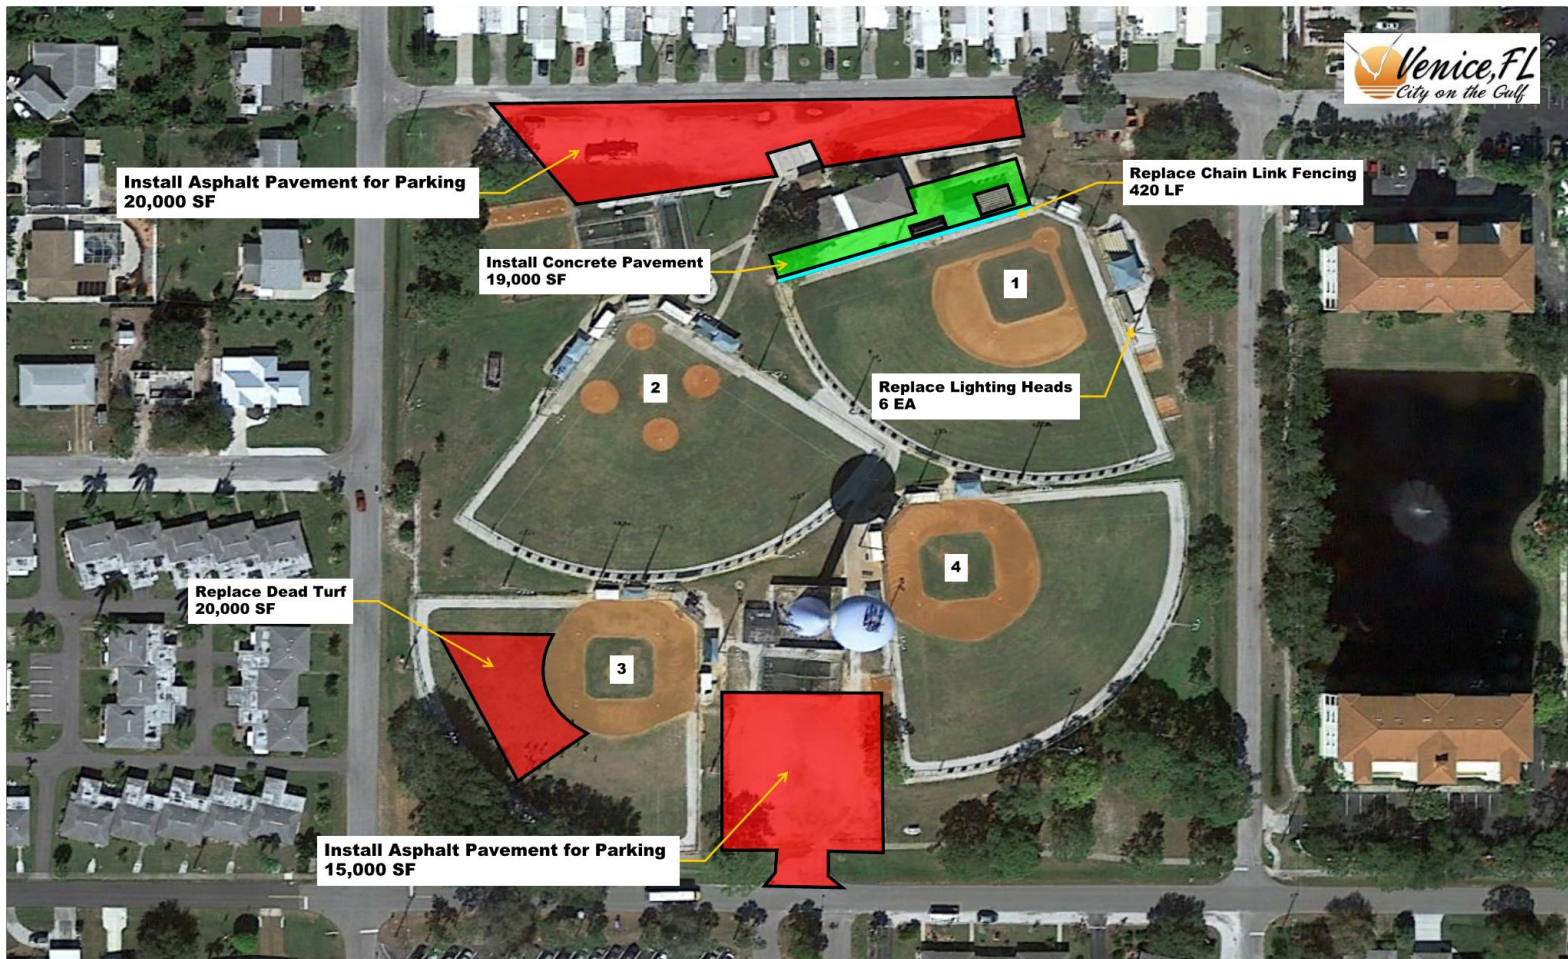
- New concrete is needed to help correct existing drainage issues which are causing the fencing to deteriorate due to standing water.
- The existing gravels parking lots need to be resurfaced with asphalt.

- The ballfield site lighting was comprised of Sportsliter Solutions lighting which was observed to be in good condition. There was rust and other signs of weather deterioration present on the lighting poles, control boxes, and fixtures. It was reported by the field personnel that the lighting on field #1 does not meet the little league field standards and needs to be replaced.

- Sports fields 1,2, and 4 were in good condition with no major deficiencies observed or reported. Field surface grading appeared to be good with no evidence of drainage problems or standing water. Sports field 3 contained a large area of dead turf which needs to be replaced.

Asset Description	Corrective Action	Notes	Current Needs
Parking Lots	Install Asphalt Parking Lots	35,000 SF @ \$7.50	\$262,500
Pedestrian Pavements	Install Concrete Pavements, 4" Thick	19,000 SF @ \$11.00	\$209,000
Site Development	Replace Site Lighting at Field #1	1 EA @ \$78,750	\$78,750
Site Development	Replace Sports Field Turf	20,000 SF @ \$0.35 SF	\$7,000
Site Development	Replace Chain Link Fencing	420 LF @ \$20 LF	\$8,400
Site Development	Repaint Dugout Benches	700 SF @ \$3.00 SF	\$2,100
Total Current Needs			\$567,750

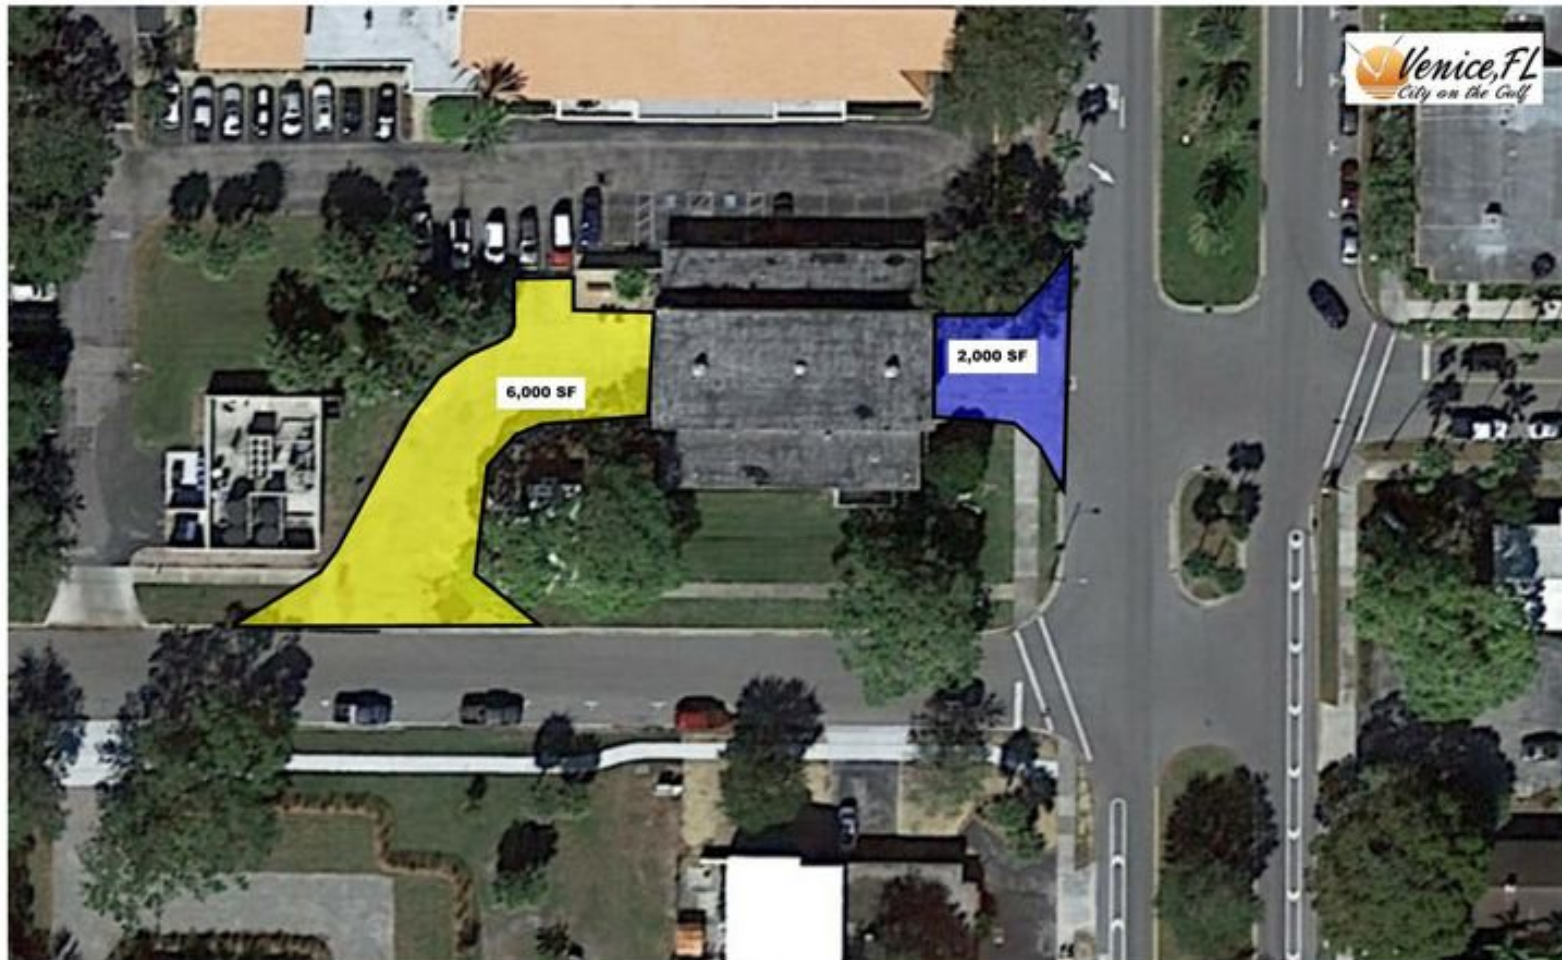
Fire Station 51

- The concrete sidewalks were in overall good condition; however, replacement of the sealant in the expansion joints as part of routine maintenance would extend their overall life
- The asphalt pavements were generally in good condition; however, crack filling, seal coating, and restriping would extend the overall life of the pavement.

Asset Description	Corrective Action	Notes	Current Needs
Pedestrian Pavements	Replace Caulking in Concrete Pavements	2,000 SF @ \$0.65 per SF	\$1,300
Vehicular Pavements	Crack Fill, Seal Coat, and Restripe Asphalt Pavements	6,000 SF @ \$1.20 per SF	\$7,200
Total Current Needs			\$8,500

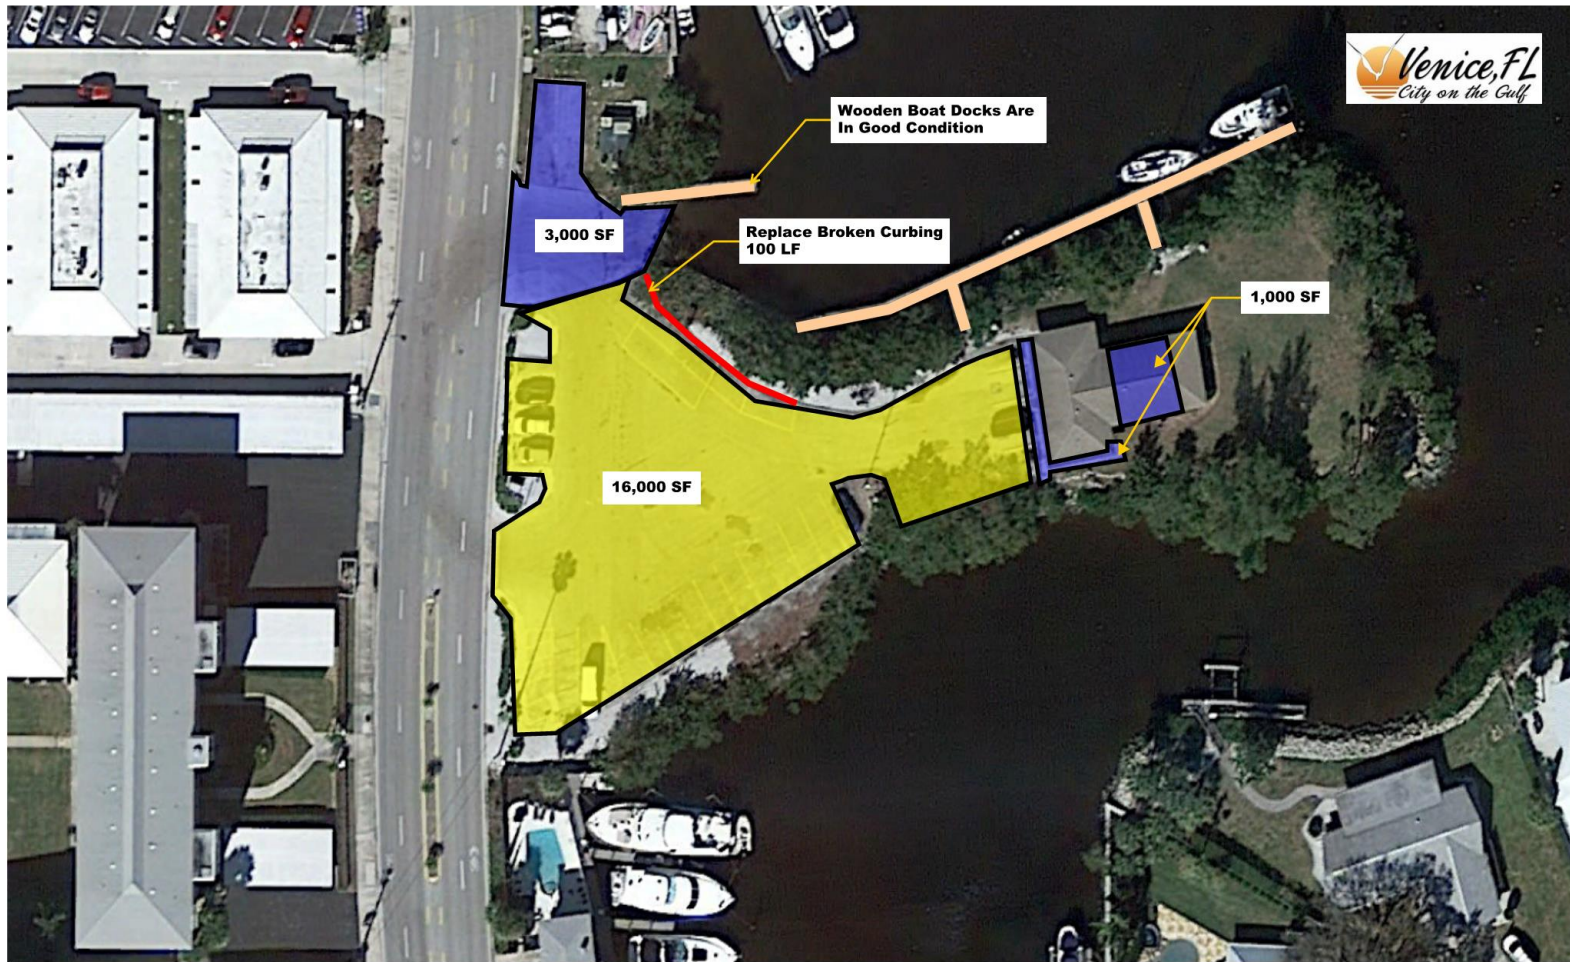
Higel Park

- The concrete sidewalks were in overall good condition; however, replacement of the sealant in the expansion joints as part of routine maintenance would extend their overall life
- The asphalt pavements were generally in good condition; however, crack filling, seal coating, and restriping would extend the overall life of the pavement.
- The site lighting appeared to be in good condition with no major issues observed or reported.
- Some of the curbing was damaged and needs to be replaced.

Asset Description	Corrective Action	Notes	Current Needs
Pedestrian Pavements	Replace Caulking in Concrete Pavements	4,000 SF @ \$0.65 per SF	\$2,600
Vehicular Pavements	Replace Curbing	100 LF @ \$35.00 LF	\$3,500
Vehicular Pavements	Crack Fill, Seal Coat, and Restripe Asphalt Pavements	16,000 SF @ \$1.20 per SF	\$19,200
Total Current Needs			\$25,300

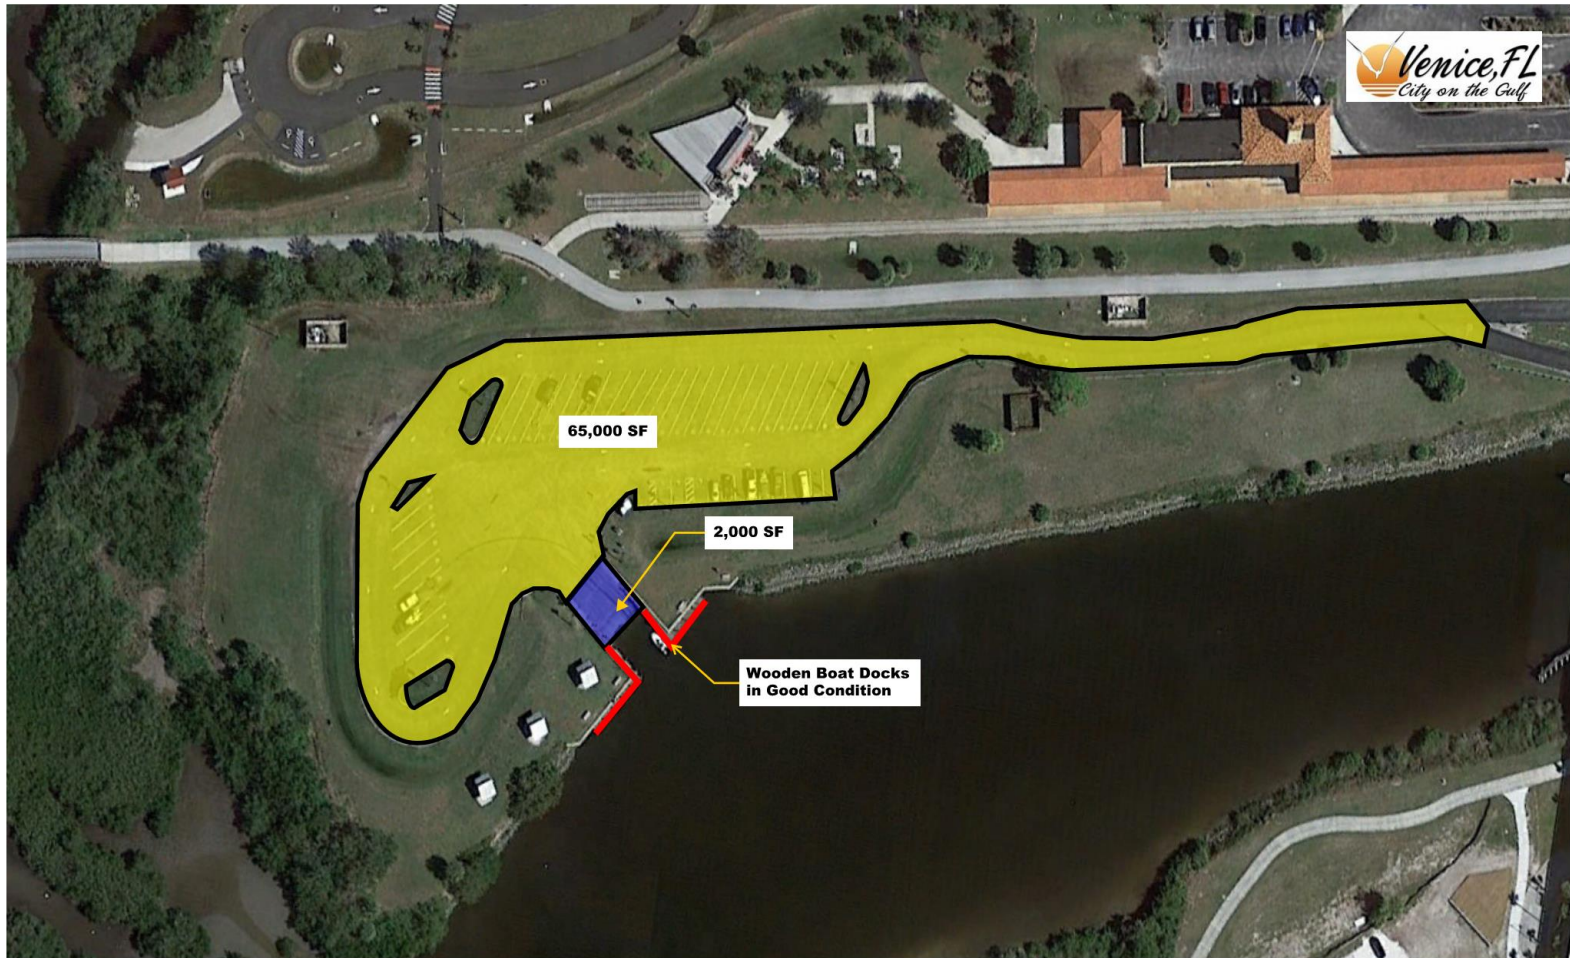
- The concrete sidewalks were in overall good condition; however, replacement of the sealant in the expansion joints as part of routine maintenance would extend their overall life
- The asphalt pavements were generally in good condition; however, crack filling, seal coating, and restriping would extend the overall life of the pavement.
- The wooden ramp and boat slips were in good condition with no issues observed or reported.
-

Asset Description	Corrective Action	Notes	Current Needs
Pedestrian Pavements	Replace Caulking in Concrete Pavements	2,000 SF @ \$0.65 per SF	\$1,300
Vehicular Pavements	Crack Fill, Seal Coat, and Restripe Asphalt Pavements	65,000 SF @ \$1.20 per SF	\$78,000
Total Current Needs			\$79,300

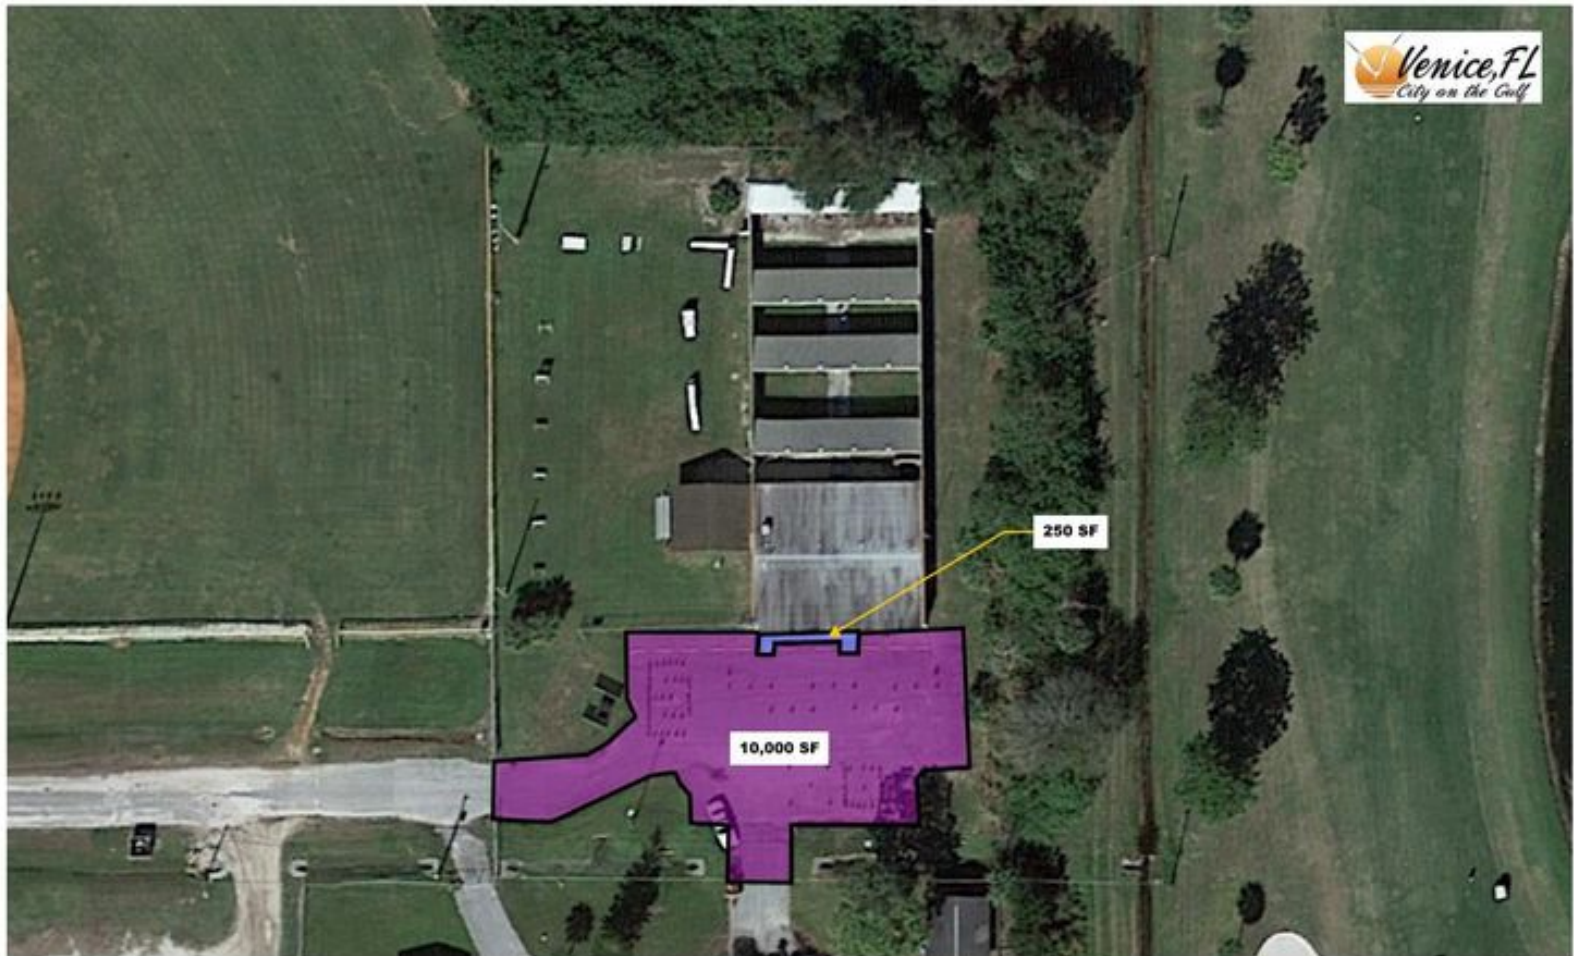
Police Firing Range

- The concrete sidewalks were in overall good condition; however, replacement of the sealant in the expansion joints as part of routine maintenance would extend their overall life
- The asphalt pavements were in poor condition and need to be resurfaced.

Asset Description	Corrective Action	Notes	Current Needs
Pedestrian Pavements	Replace Caulking in Concrete Pavements	250 SF @ \$0.65 per SF	\$162.50
Vehicular Pavements	Resurface Asphalt Pavements	10,000 SF @ \$3.50 per SF	\$35,000
Total Current Needs			\$35,162.50

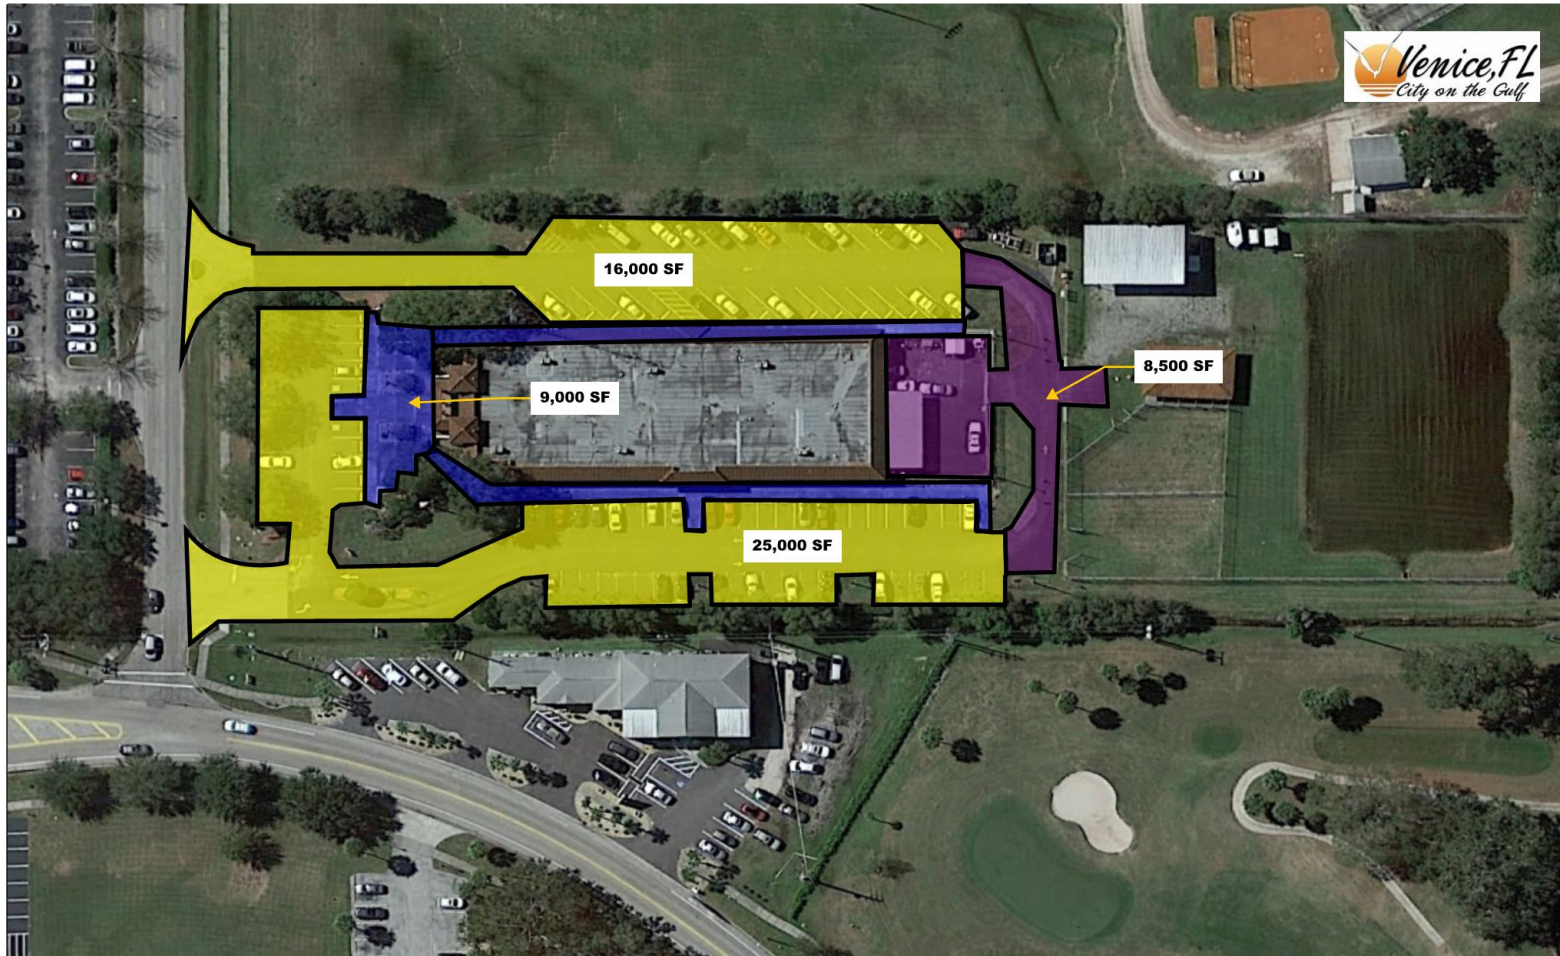
Police Station

- The concrete sidewalks were in overall good condition; however, replacement of the sealant in the expansion joints as part of routine maintenance would extend their overall life
- The concrete curbs are in good condition with no issues observed at the time of the assessment.
- The asphalt pavements were generally in good condition except for a few isolated areas. Crack filling, seal coating, and restriping would extend the overall life of the pavement.
- There were some areas of damaged or deteriorated asphalt pavements that need to be resurfaced.

Asset Description	Corrective Action	Notes	Current Needs
Pedestrian Pavements	Replace Caulking in Concrete Pavements	9,000 SF @ \$0.65 per SF	\$5,850
Vehicular Pavements	Crack Fill, Seal Coat, and Restripe Asphalt Pavements	41,000 SF @ \$1.20 per SF	\$49,200
Vehicular Pavements	Resurface Asphalt Pavements	8,500 SF @ \$3.50 per SF	\$29,750
Total Current Needs			\$84,800

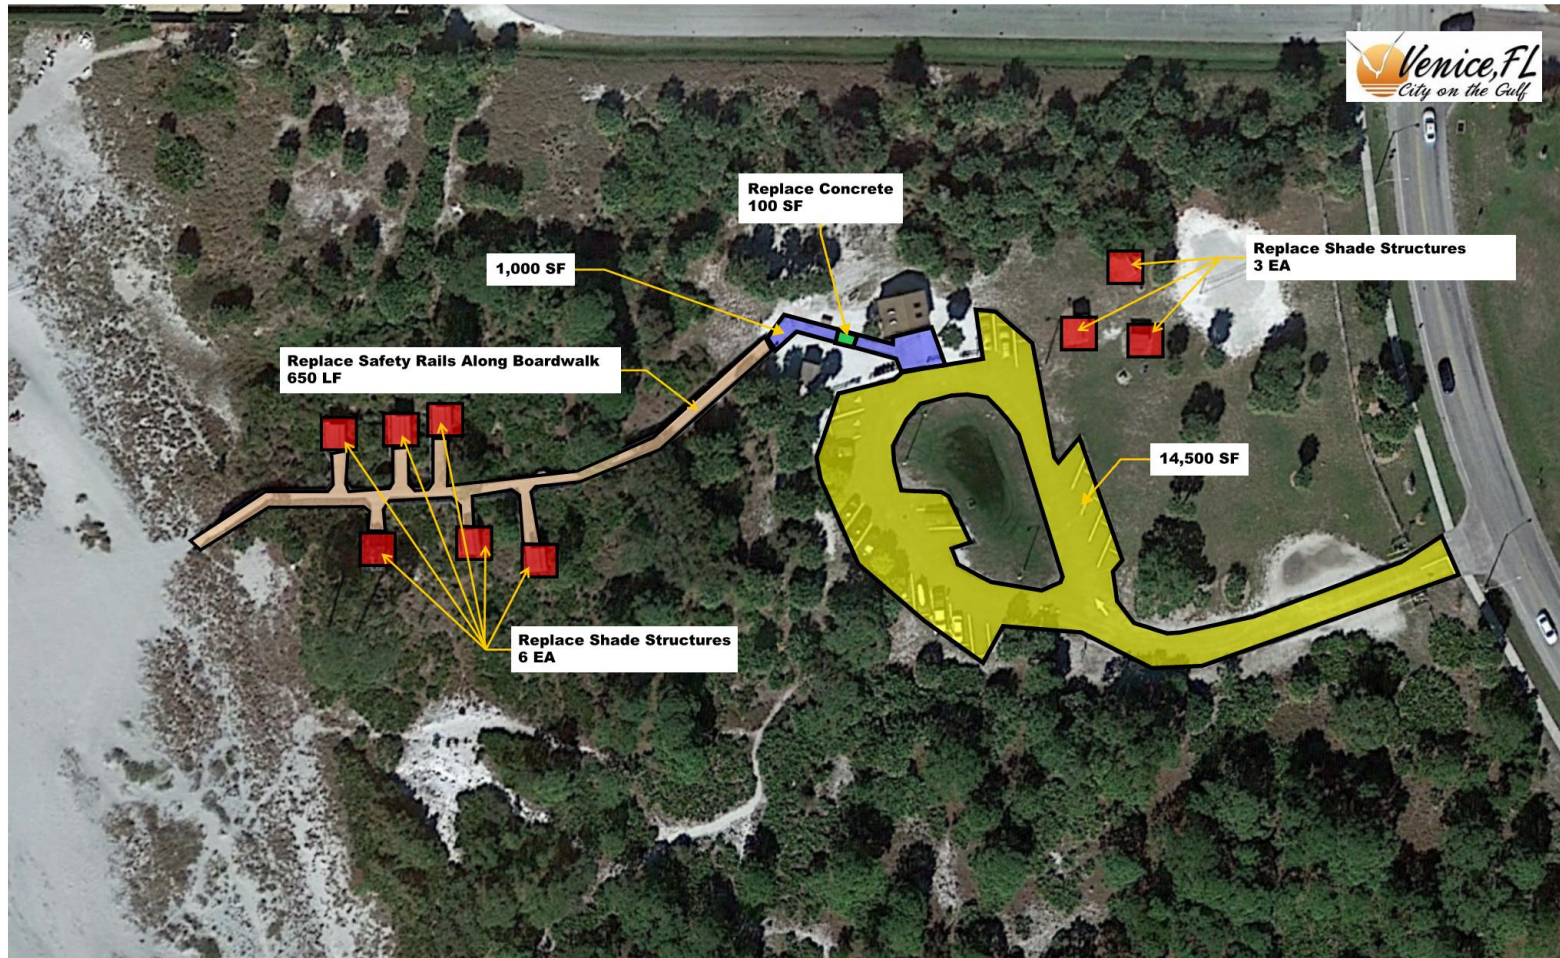
- The concrete sidewalks were generally in good condition except for a few isolated areas, which need to be replaced. Furthermore, replacement of the sealant in the expansion joints as part of routine maintenance would extend their overall life.
- The asphalt pavements were generally in good condition; however, crack filling, seal coating, and restriping would extend the overall life of the pavement.
- The wooden boardwalk which leads from the parking lot to the beach is in fair condition. The composite flooring was observed to be in good condition; however, the safety railing was in poor condition. Rotting wood, deteriorated mounting hardware, and other deficiencies were observed.
- The wooden shade structures were observed to be in poor condition and need to be replaced. Missing and rotting boards were present.

Asset Description	Corrective Action	Notes	Current Needs
Site Development	Replace Safety Railing	650 LF @ \$ 18 LF	\$11,700
Site Development	Replace Wooden Shade Structures	9 EA @ \$2,500 EA	22,500
Pedestrian Pavements	Replace Caulking in Concrete Pavements	1,000 SF @ \$0.65 per SF	\$650
Pedestrian Pavements	Replace Concrete Pavements; 4" Thick	100 SF @ \$11 per SF	\$1,100
Vehicular Pavements	Crack Fill, Seal Coat, and Restripe Asphalt Pavements	14,500 SF @ \$1.20 per SF	\$16,800
Total Current Needs			\$52,750
